**FIRE, FLOOD, AND LANDSLIDE DAM HISTORY:
COMMUNITY OF MONTECITO AND VICINITY
SOUTHERN SANTA BARBARA COUNTY, CALIFORNIA**

THE PROJECT FOR
RESILIENT COMMUNITIES

LARRY D. GURROLA, Ph.D., P.G., C.E.G.

February 25, 2022

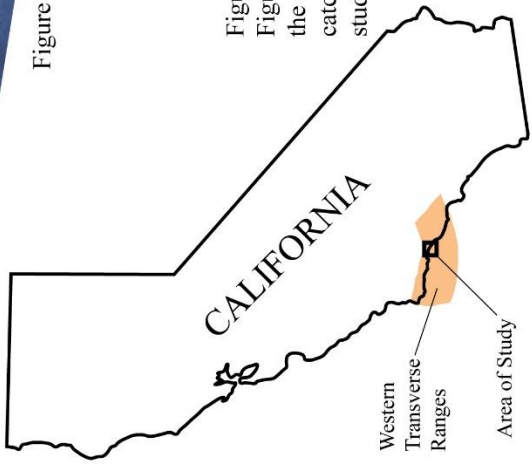
Figure 1A.

Figure 1A (Left). Location of the western Transverse Ranges in southern California.
 Figure 1B (Above). The communities of Santa Barbara, Montecito, and Carpinteria are situated below the steep slopes of the Santa Ynez Mountains on the coastal plain. The main canyons of the mountain catchments that discharge sediment and water onto the plain are shown. These watersheds form the study area that is shown as an orange, dashed line.

This history evaluation tallies flood events that occurred in watersheds located south of the of the Santa Ynez Mountain ridge divide between Gaviota to the west and Carpinteria to the east (Figure 1B). From west to east, the communities of Goleta, Santa Barbara, Montecito, and Carpinteria are located at the base of the Santa Ynez Mountains on a coastal plain. Special focus was placed on events that occurred within the extent of the community of Montecito and adjacent watersheds including the creeks of Cold Springs, Hot Springs, Oak Creek, San Ysidro, Buena Vista, Romero and Picay (Figure 5).

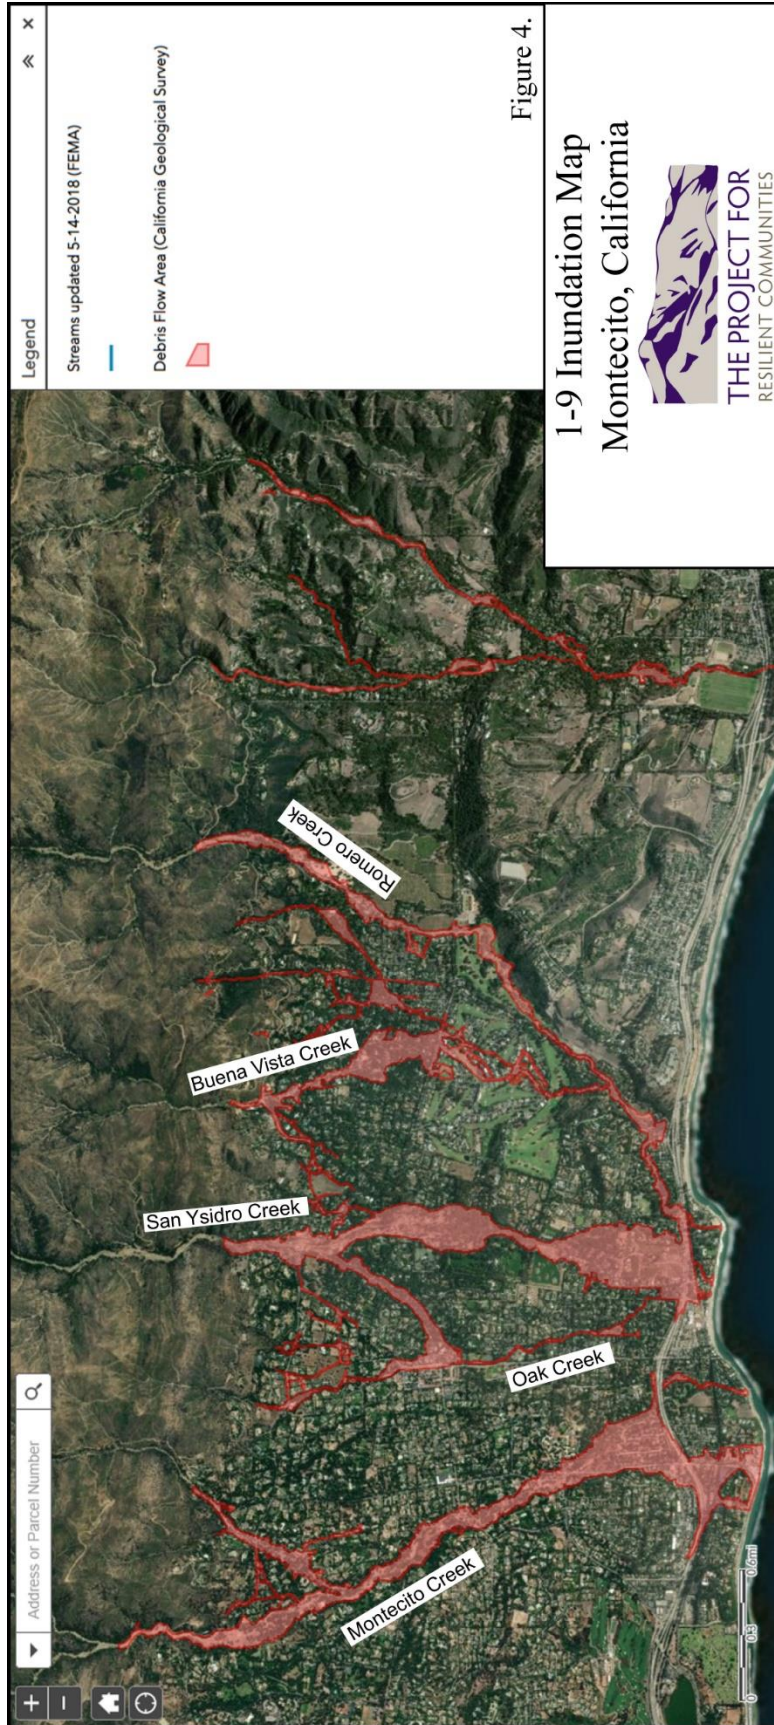
Debris flow inundation map following the January 9, 2018 event by the California Geological Survey (2018). The extent of the inundation exhibits the nature of debris flow avulsions producing out-of-channel flows. The flows spread out onto the alluvial fan surface that the community is developed on.

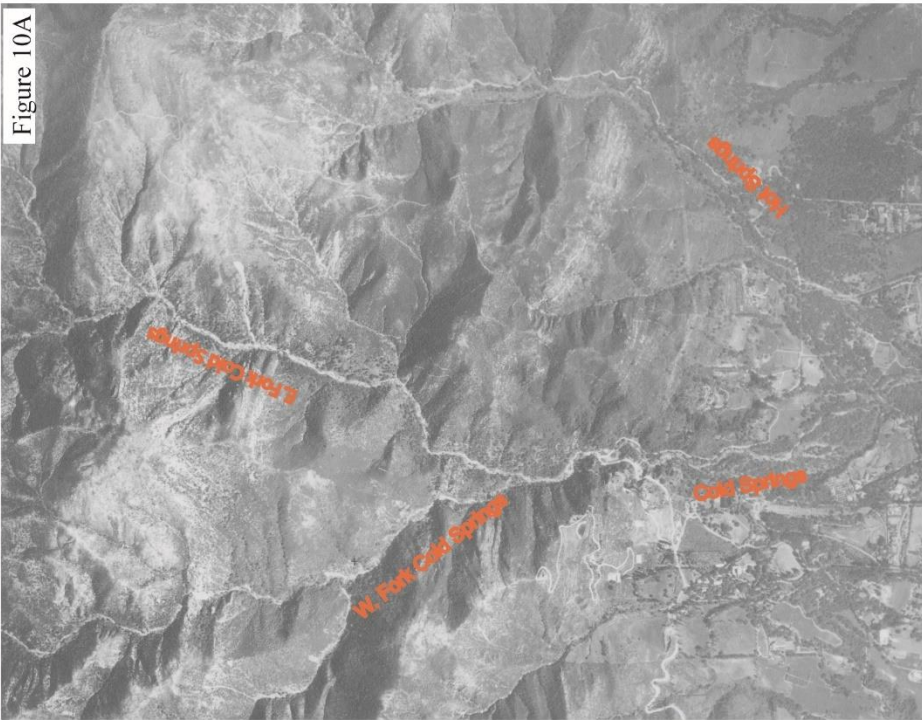
Figure 10A

Figure 10A. Aerial photograph flight C-430, frame C-44, dated, 1929 showing the steep terrain in the lower watersheds of Cold Springs and Hot Springs Canyon. Figure 10B. Large, deep seated landslides are shown outlined with red dashed lines and head scarps marked by red hatchures. The landslide observed by Colonel Slosson in 1909 following heavy rainfall forms a steep headscarp area. Note the large mass of landslide debris at the bottom of the slope with the creek channel deflected westward. Other deep seated landslides are shown in the vicinity and these slides present potential dam forming blockages of the watershed.

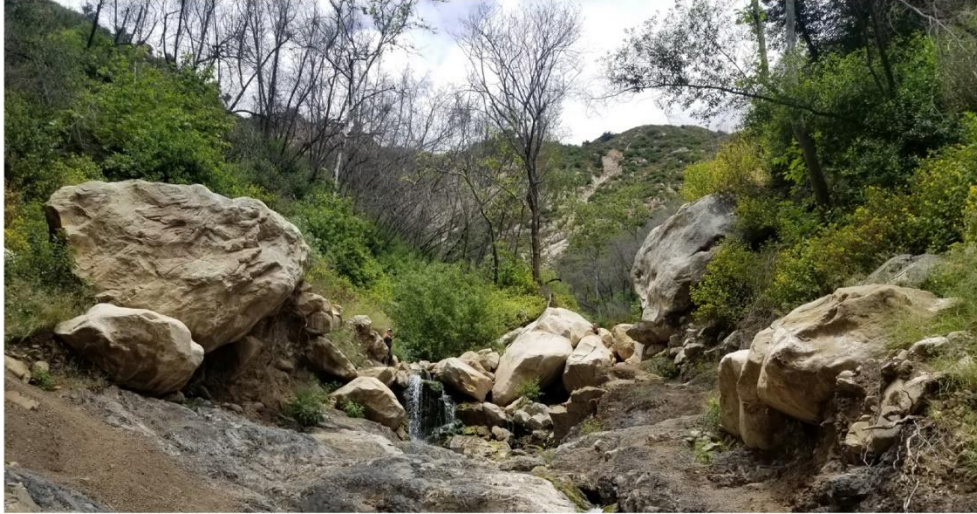
Figure 12A. View looking north, upstream of the east fork of Cold Springs Creek at the 1909 landslide dam remnant. The slide moved downlope from right to left over running and burying the former creek channel. A new creek channel was formed west of the former channel location where the flood breakout occurred.

Another newspaper account in The Morning Press (dated February 9, 1909) headlined an article “*Big landslide on Mountain.*” This article noted that a remarkable landslide occurred during the storm on the north shoulder of Cold Springs Canyon. More importantly, the article stated the landslide created a “*great gash*” down the mountain side and the scar was plainly visible with the naked eye from the windows of any three-story building on State Street. Based on the description that it is visible with the naked eye from State Street and was on the highest peak south (east) of La Cumbre peak forming the north shoulder of Cold Springs Canyon, this landslide appears to have occurred on the southwest-facing slope of the peak west of Montecito Peak (Plate 1; Figure 9).

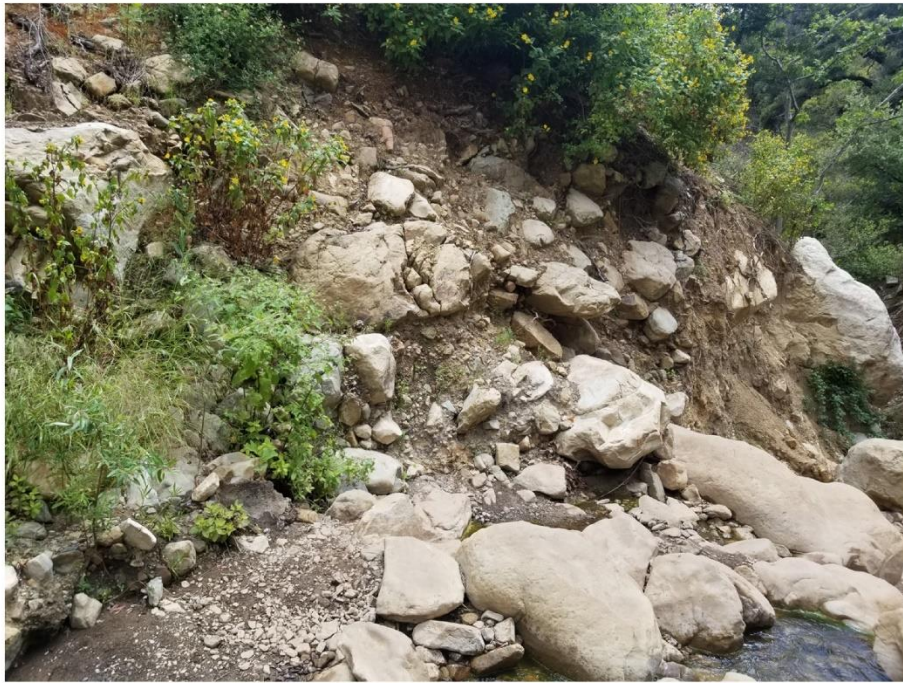
Figure 12B. The toe of the landslide is exposed in the eastern bank and reveals sandstone sandstone derived debris that now forms a steepened scarp. Recent scour erosion has partially exposed the basal slide plane.

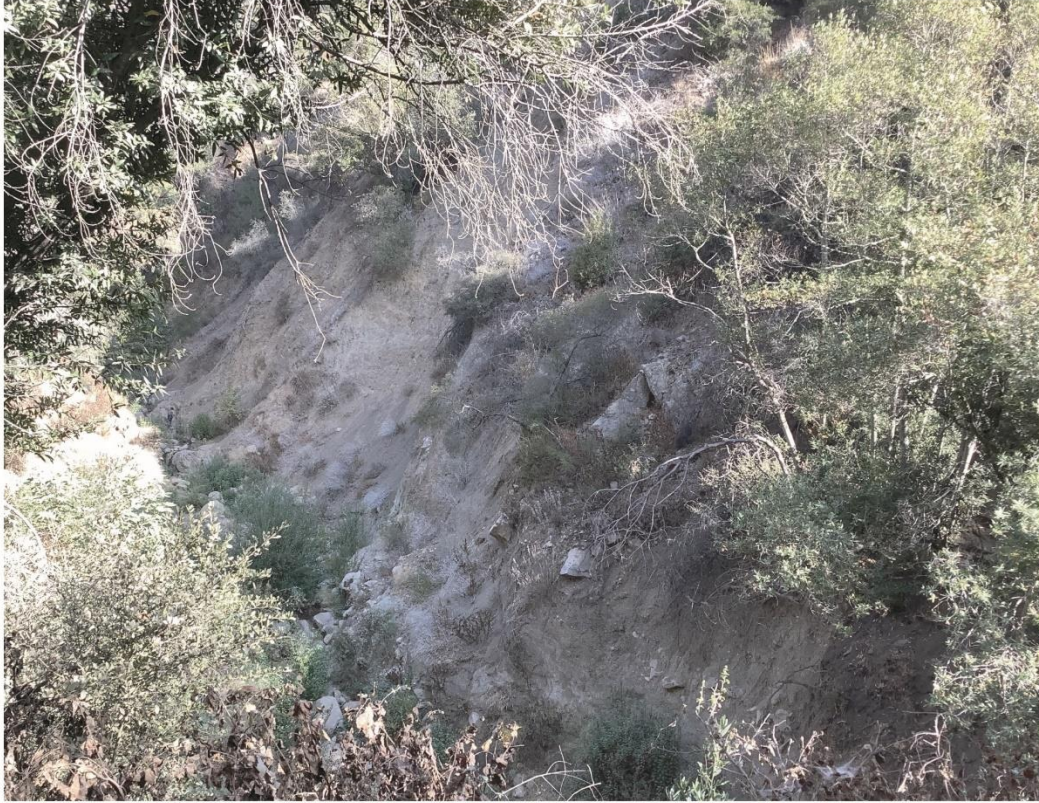
Figure 13.

View of the toe of the large landslide located south of the confluence of the west and east forks of Cold Springs Creek. This landslide has the potential to block flow on both west and east tributary forks which has the potential to produce a much larger outbreak flood as compared to the 1909 landslide.

A second, large landslide that produced previous landslide dams is located south of the 1909 slide and currently poses a greater flood threat (Plate 2; Figures 9, 10A, and 10B). The large slump forms a bench composed of shale-siltstone blocks in a finer-grained matrix. This slump likely produced a landslide dam because of size of the mass, extent of displacement, and the narrow width of the incised drainage. It poses a greater flood hazard because it potentially blocks both a second western tributary of Cold Springs Creek, in addition to the tributary with the 1909 landslide. As a result, a much larger temporary lake may be formed from both tributaries producing a greater outbreak flood (Figure 13). Reactivation of the toe has resulted in subsequent smaller slides of the

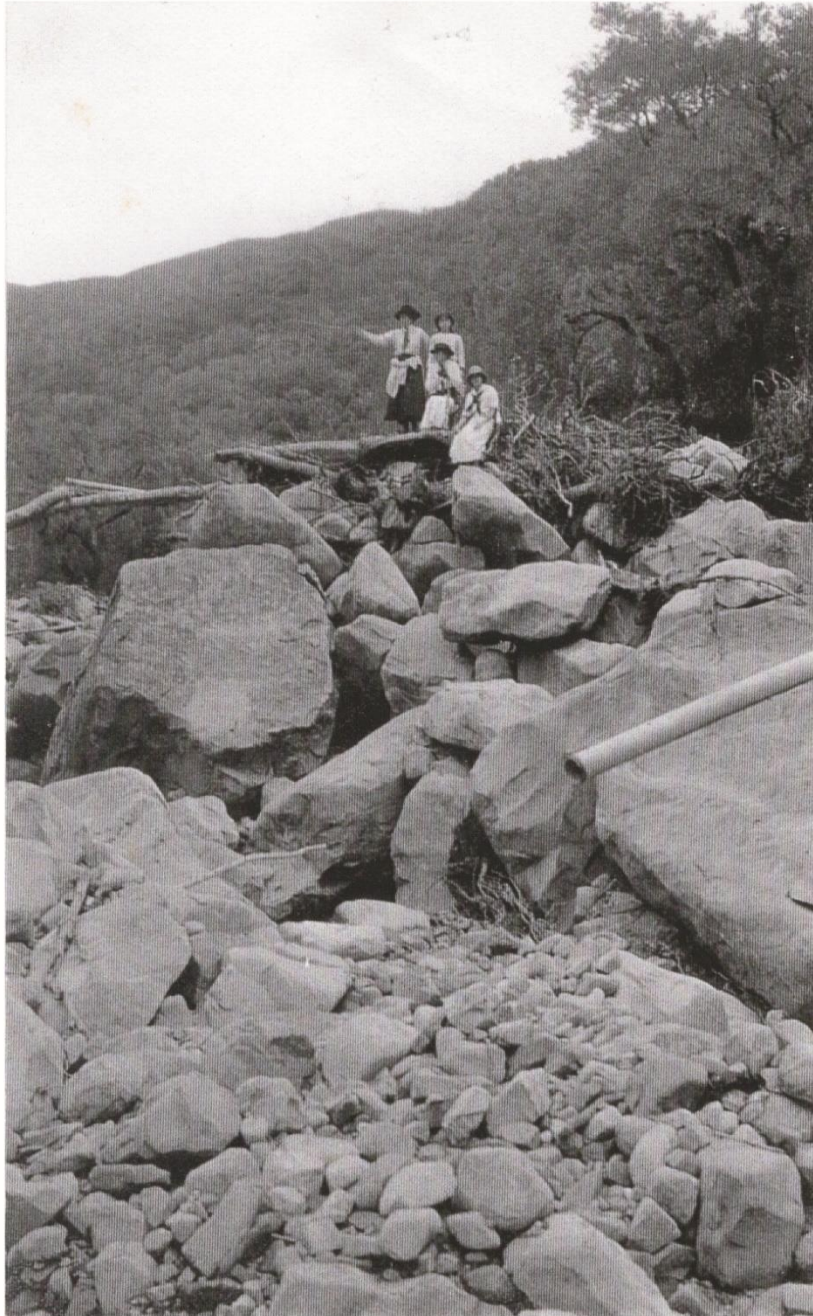
A debris plug in the channel of Hot Springs Creek was a source of fascination for the locals. Not all debris flows exit the canyon mouth. This debris flow froze in place in Hot Springs canyon likely due to dewatering of the flow. The photograph shows an escarpment approximately 20 feet in height. Courtesy of the Montecito Association History Committee.

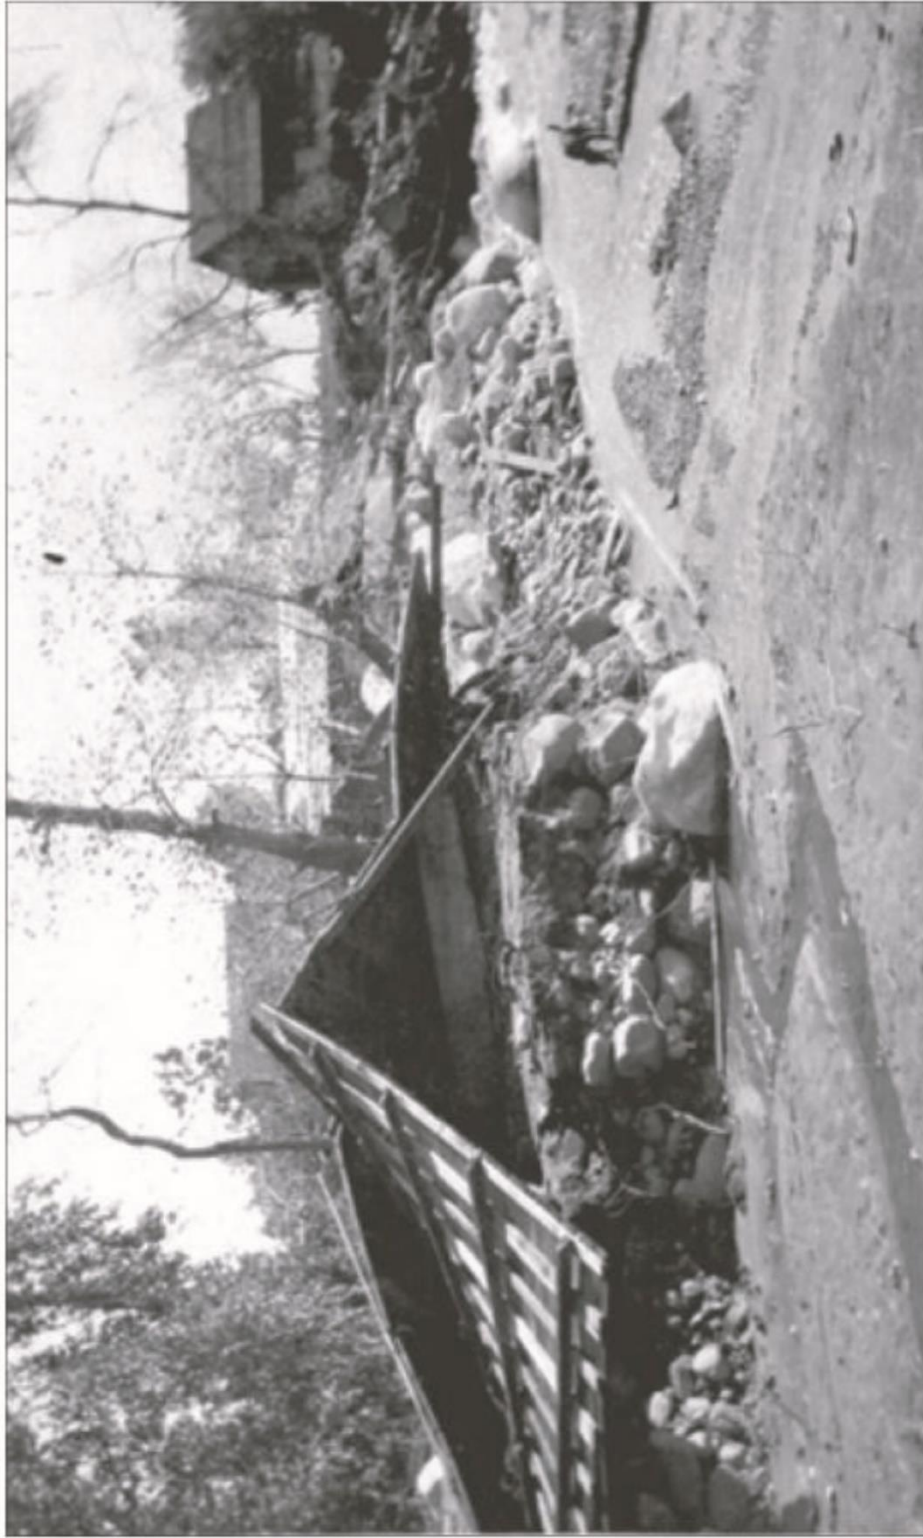
Debris flows caused devastation in Old Spanish Town on January 25, 1914 and again on February 18, 1914. A roof sits on a pile of boulders and mud outside of Montecito Creek. Photograph from Noticias, October 2019.

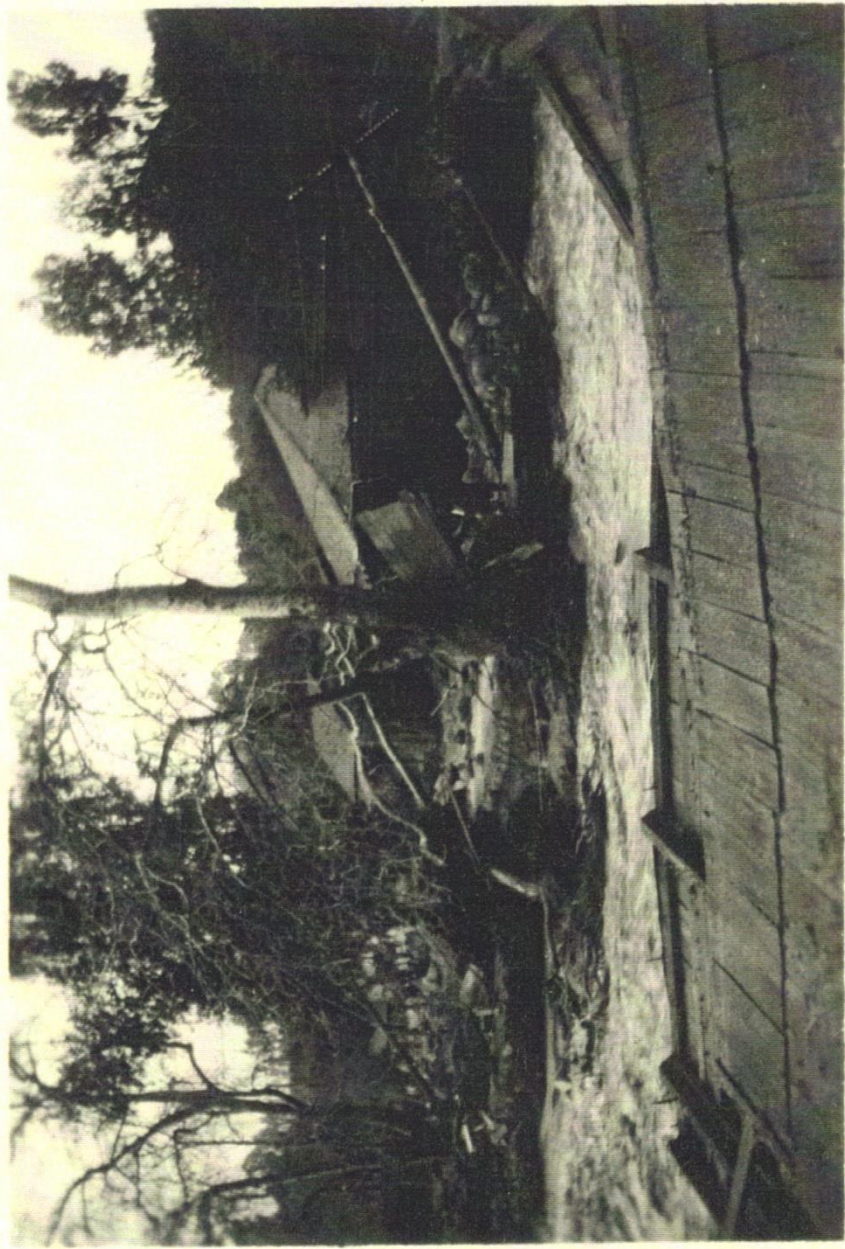
Located along the banks of Montecito Creek, Old Spanish Town suffered extensive damage with the loss of over a dozen buildings and an early period Spanish adobe building. The Morning Press newspaper reported a story entitled, "Old Town Wiped From Montecito Map". The main bridge on Montecito Creek was constructed of stone which caused a debris blockage that ultimately collapsed. The blockage diverted the creek to flow around the west abutment producing much damage by impacts of trees and boulders. Photograph courtesy of the Montecito Association History Committee.

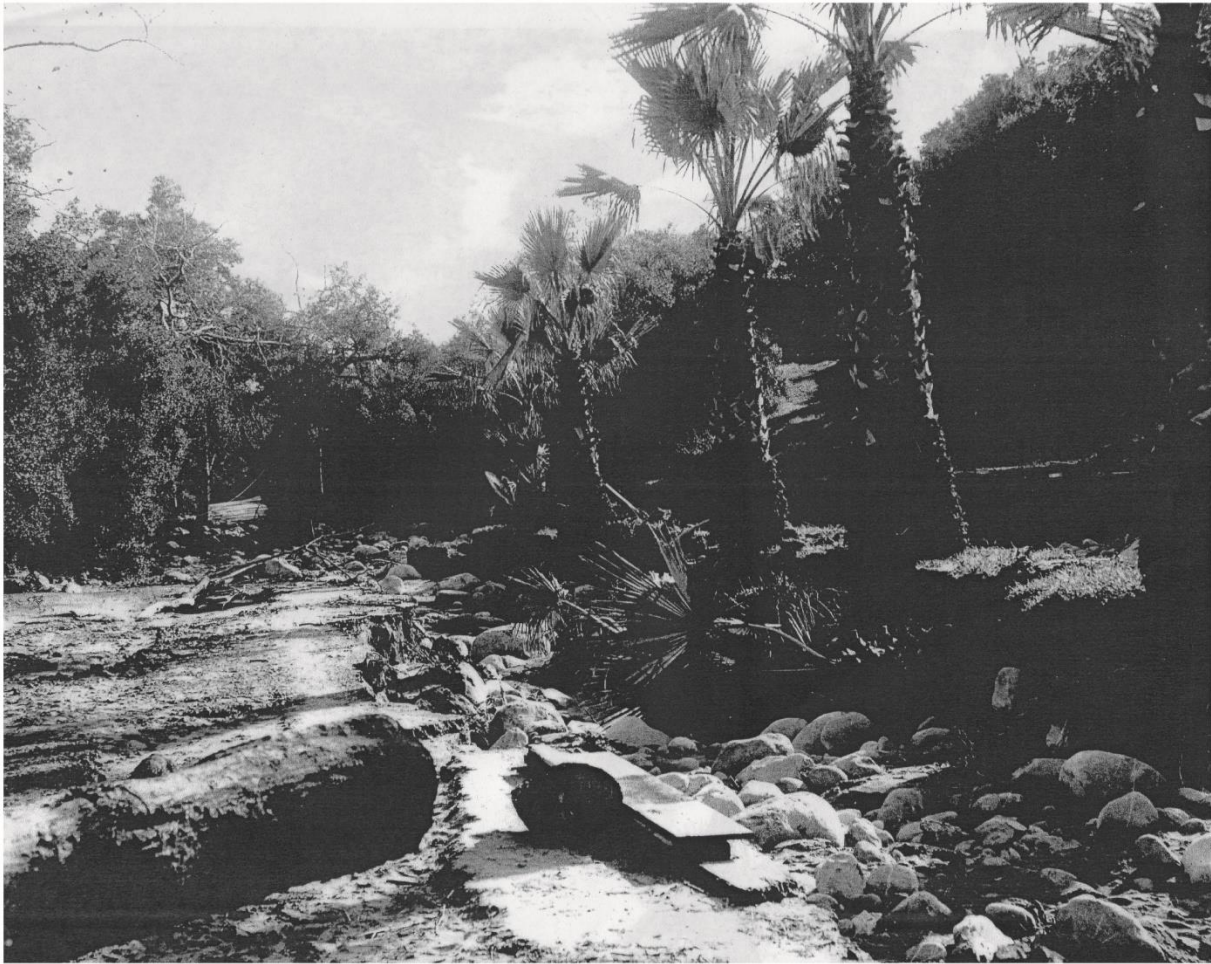
View of Olive Mill Road where debris flows broke out-of-channel from Montecito Creek at the Hot Springs Road bridge overpass. The avulsion diverted flows down Olive Mill Road incising a gully up to 20 feet deep, in places. This photograph shows boulder and vegetation debris partially filling the gully. Debris flows on February 18, 1914 once again broke out-of-channel at this location during the second debris flow event and scoured another gully similar to this event. Photograph courtesy of the Montecito Association History Committee.

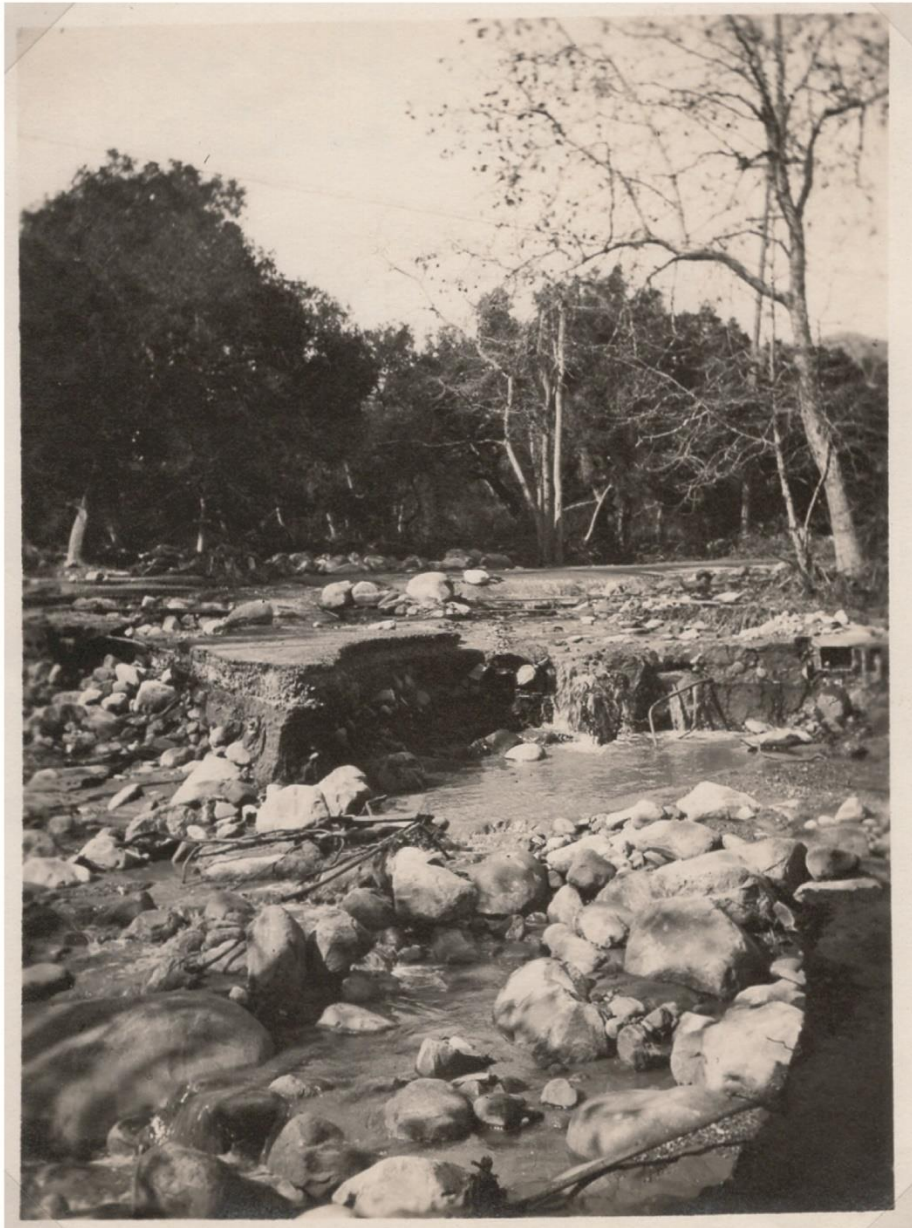
A different view of Olive Mill Road at the juncture of Hot Springs Road and Olive Mill Road after the flood had subsided following the first event. Photograph courtesy of the Montecito Association History Committee.

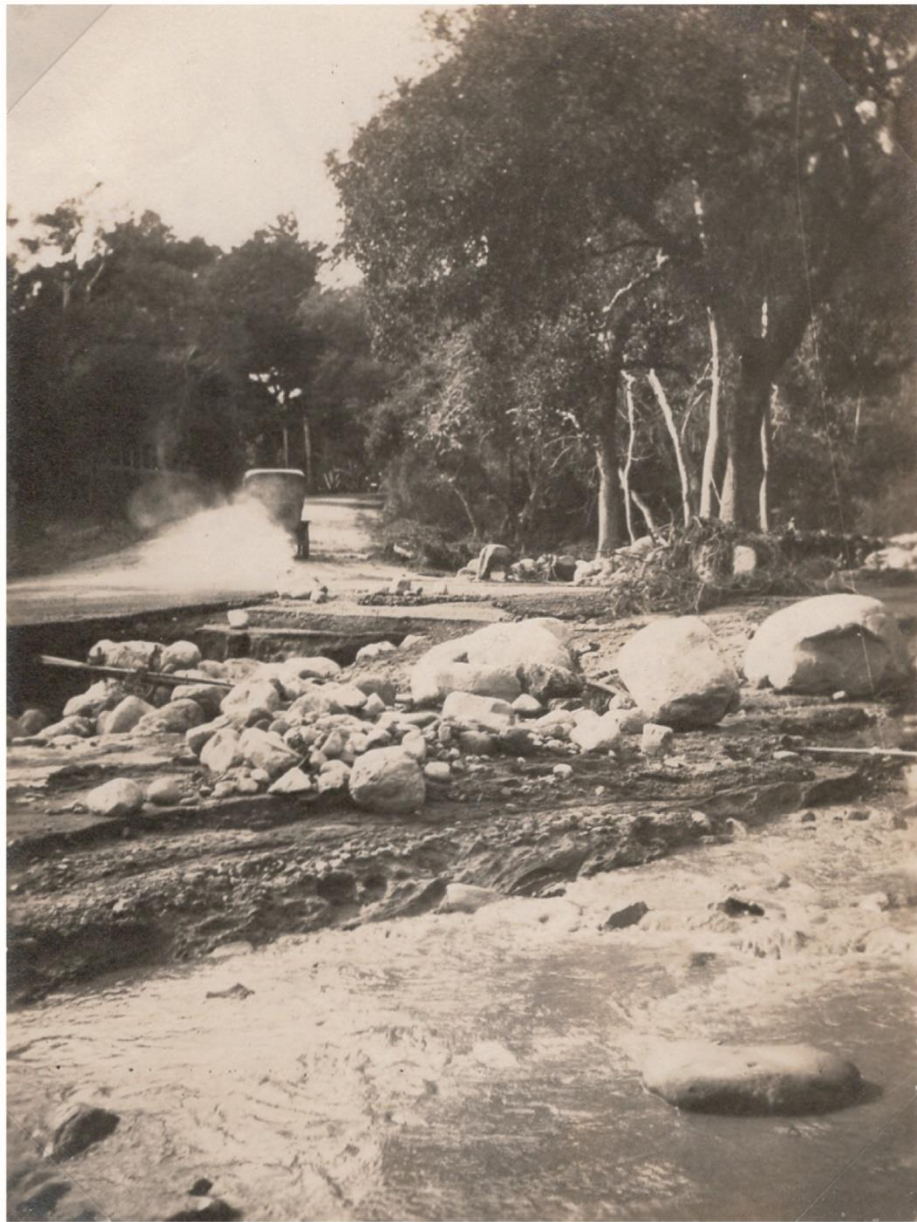
View looking along Hot Springs Road at the intersection of Olive Mill Road after the floodwaters had subsided. The out-of-channel flows down the Olive Mill Road corridor re-occurred during the second debris flow event on February 18, 1914. Photograph courtesy of the Montecito Association History Committee.

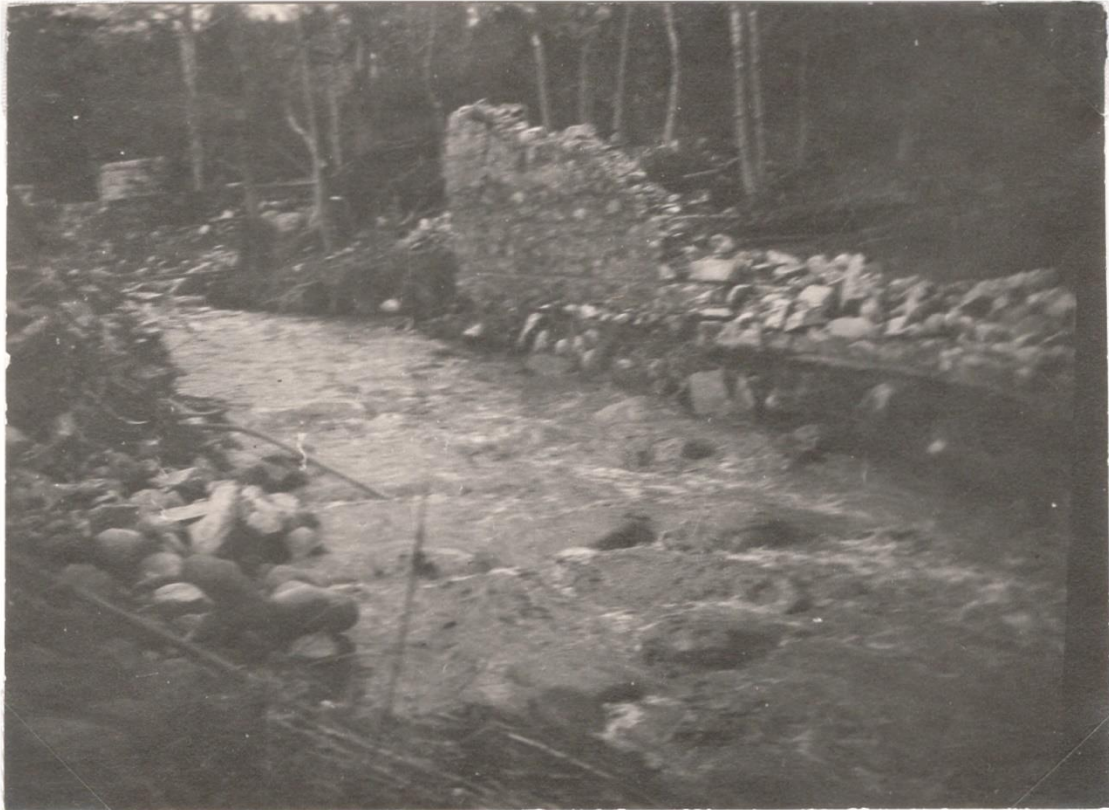
The January 25, 1914 debris flow path down Olive Mill Road destroyed the stone lemon house on William Gould's La Favorita property, located southwest of the Olive Mill Rd and Hot Springs Road intersection. This photograph shows the remains of the stone lemon house. The normal channel course of Montecito Creek is located east of Olive Mill Road at this location. Photograph courtesy of the Montecito Association History Committee.

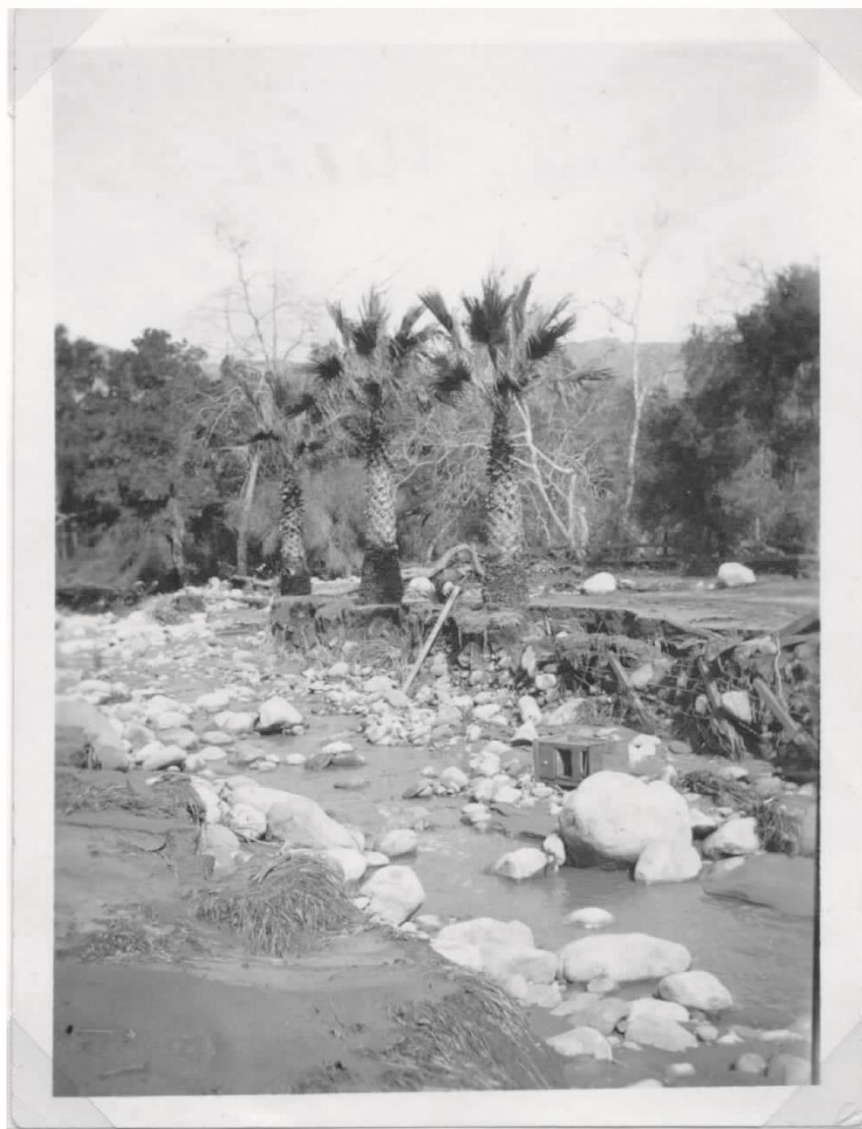
Another view showing the result of out-of-channel debris flows diverted down Olive Mill Road in the first 1914 event. This photograph is in the vicinity of the intersection with Hot Springs Road. Debris flows traversed this road corridor once again on February 18, 1914 after a blockage at the Hot Springs bridge overpass diverted flows onto Olive Mill Road. Photograph courtesy of the Montecito Association History Committee.

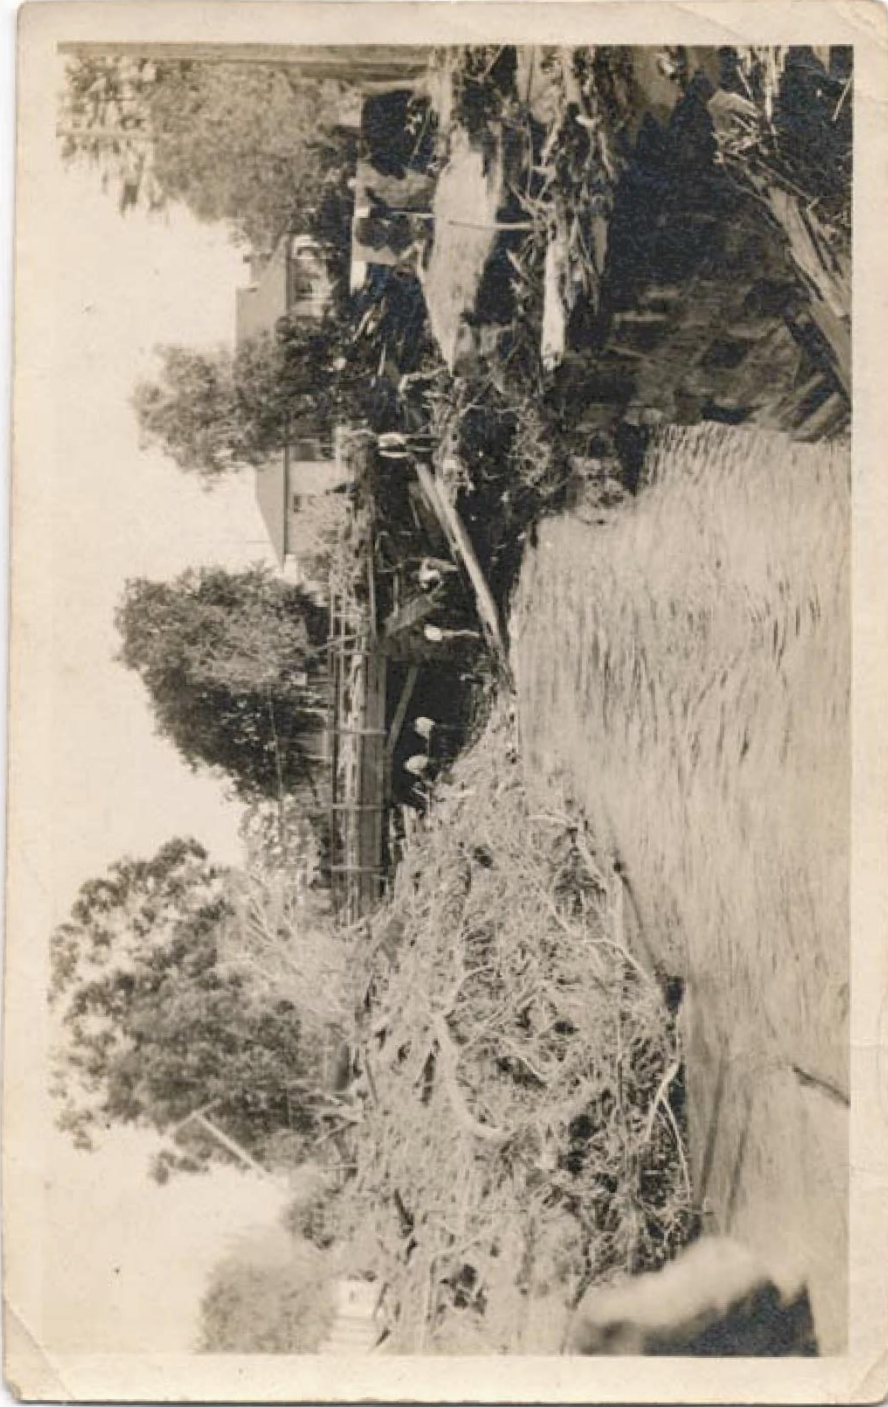
Clean up and removal of vegetative debris at a bridge constriction resulted in avulsion and diversion of flows. Photograph from Edson Smith Photo Collection, Santa Barbara Library, 2020.

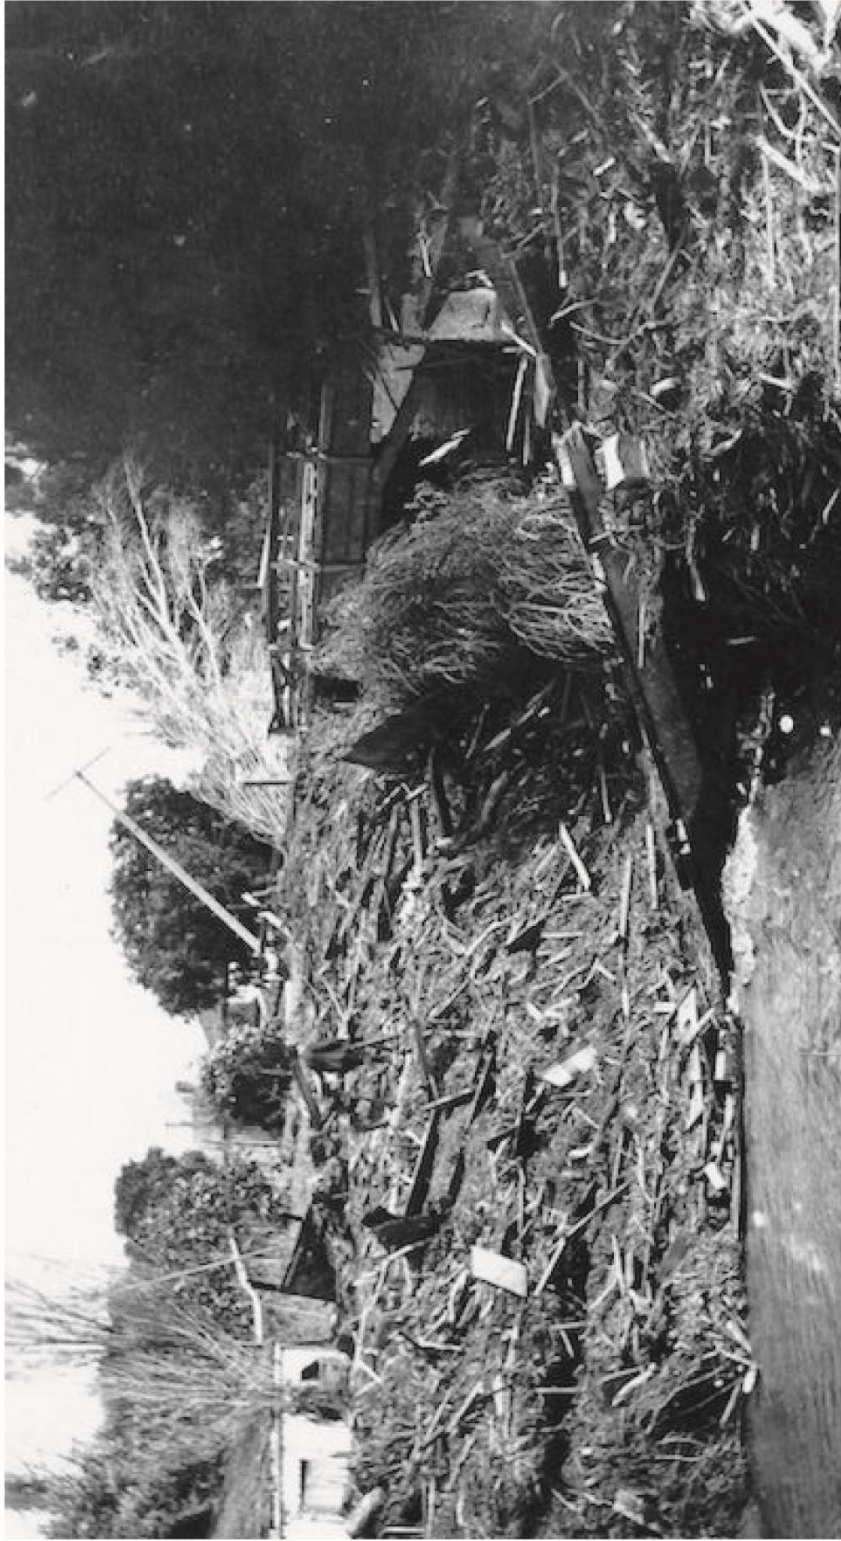
Debris choked bridge on Mission Creek depicts the vast amounts of vegetative and other debris produced in the 1914 event. Photograph from Edson Smith Photo Collection, Santa Barbara Library, 2020.

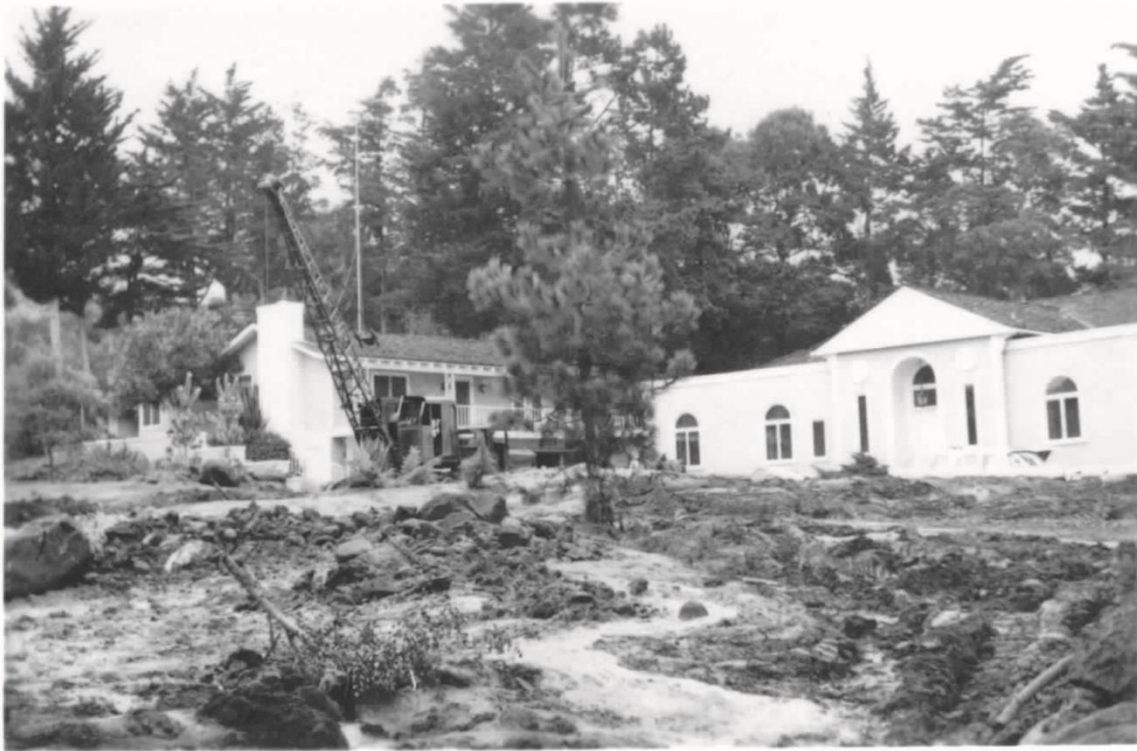
Boulder debris and mud choke the channel of Hot Springs Creek (foreground) in Riven Rock. Once the channel filled with debris, flows were diverted on to the fan which resulted in homes inundated with feet of mud.

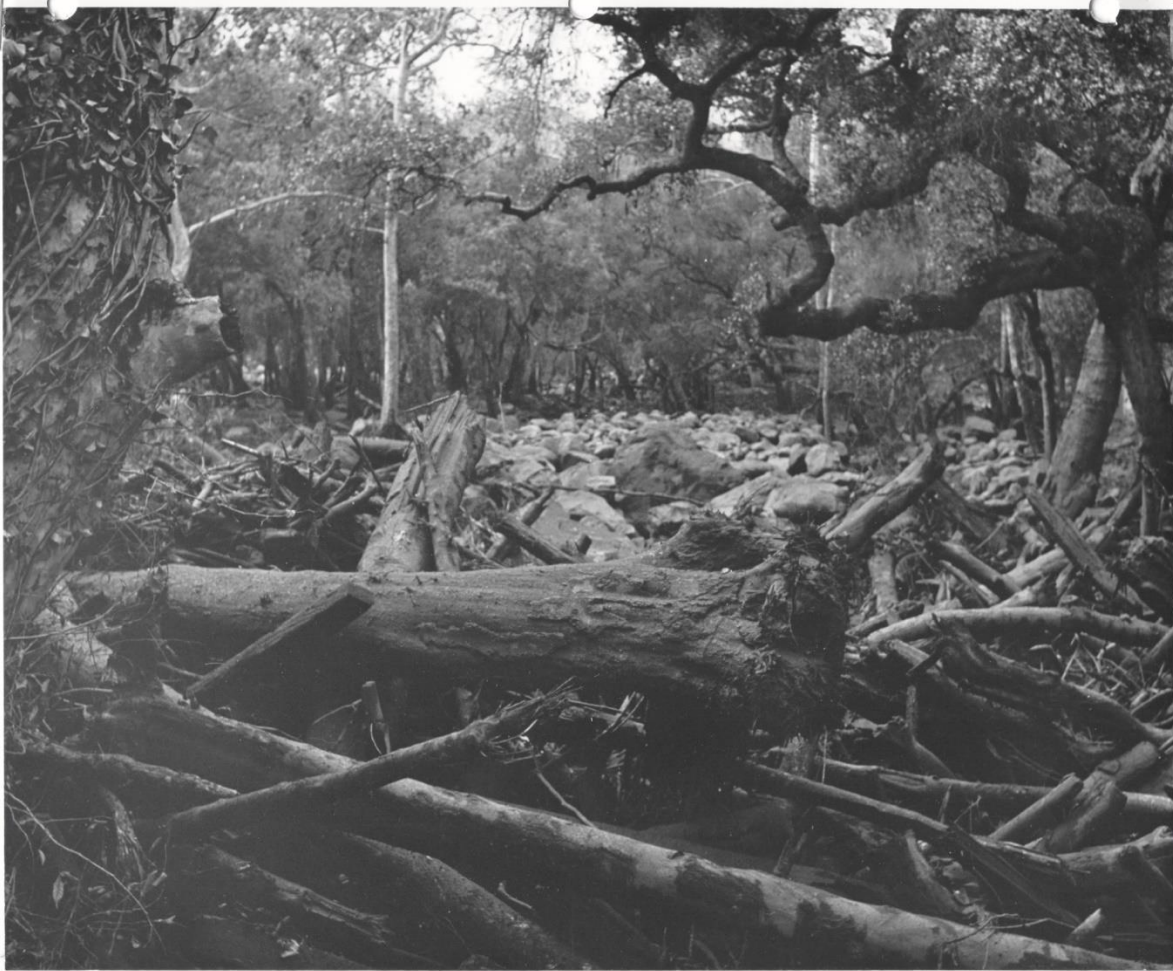
View of Cold Springs Creek looking upstream of the blockage at Ashley Road bridge. Vast amounts of tree log debris formed this extensive blockage at the bridge constriction which blocked the flow and filled the creek channel with boulder debris behind it. Photograph courtesy of the Montecito Association History Committee.

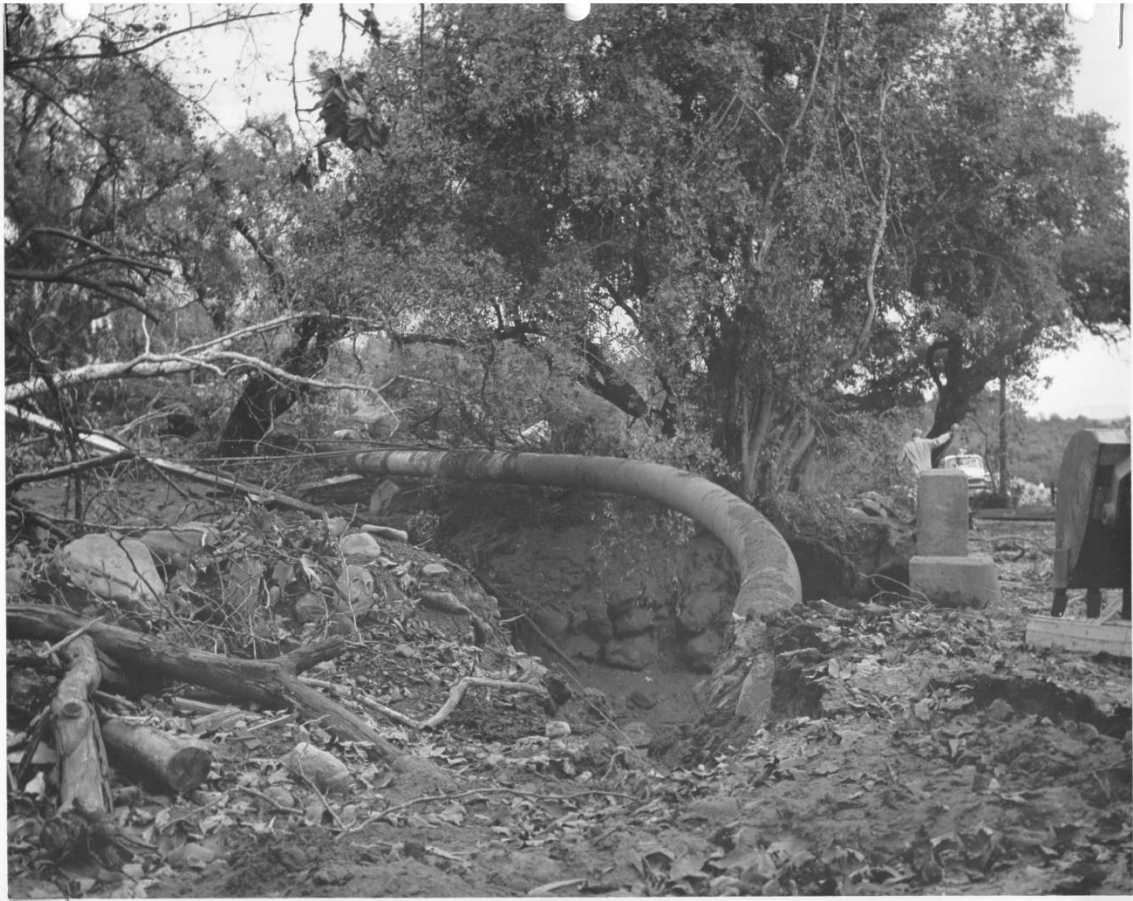
Photograph taken on San Ysidro Creek at the Mountain Drive bridge showing the damage done to a gas main pipeline. This is the same general location that the 1-9 debris flows triggered a gas pipeline rupture and explosion. Photograph courtesy of the Montecito Association of History Committee.

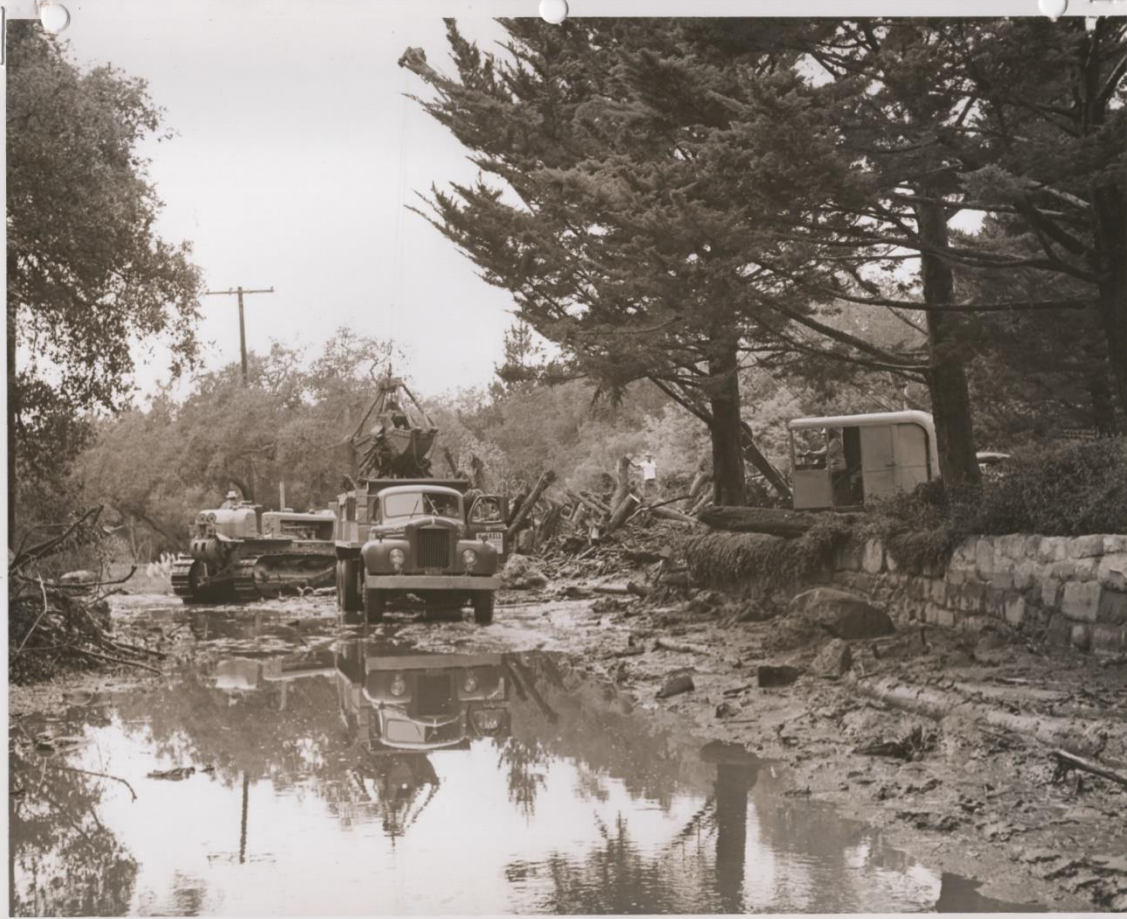
The November 9, 1964 debris flows discharged voluminous amounts of tree and boulder debris from the mountain watersheds creating blockages at creek channel constrictions. This photograph shows a view looking east at the San Ysidro Creek bridge crossing on Highway 192. Note the tremendous amounts of vegetative debris stacked up on the upstream side of the bridge in the center of the photograph. Later, this bridge was demolished to allow for future debris flows to pass by this constriction point. Photograph courtesy of the Montecito Association History Committee.

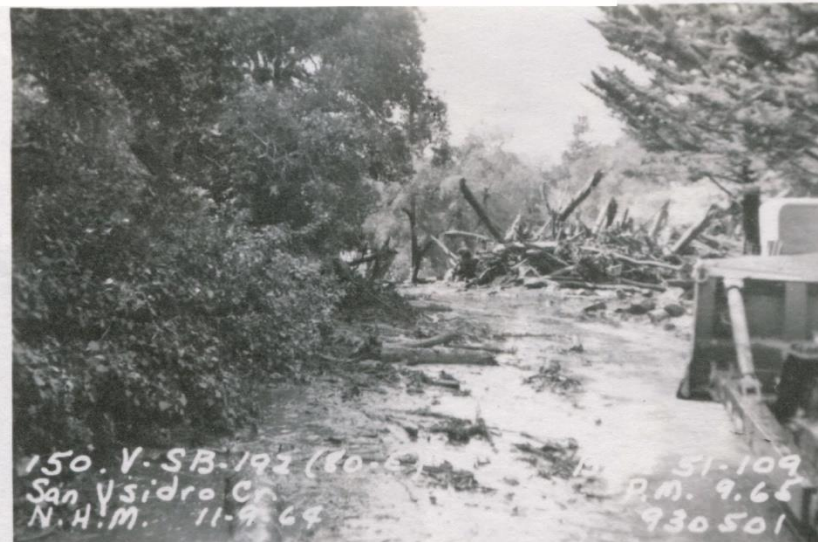
Figure 31A. Photograph of the log jam that blocked the bridge constriction at Highway 192 on San Ysidro Creek .
