**FIRE, FLOOD, AND LANDSLIDE DAM HISTORY:
COMMUNITY OF MONTECITO AND VICINITY
SOUTHERN SANTA BARBARA COUNTY, CALIFORNIA**

THE PROJECT FOR
RESILIENT COMMUNITIES

LARRY D. GURROLA, Ph.D., P.G., C.E.G.

February 25, 2022

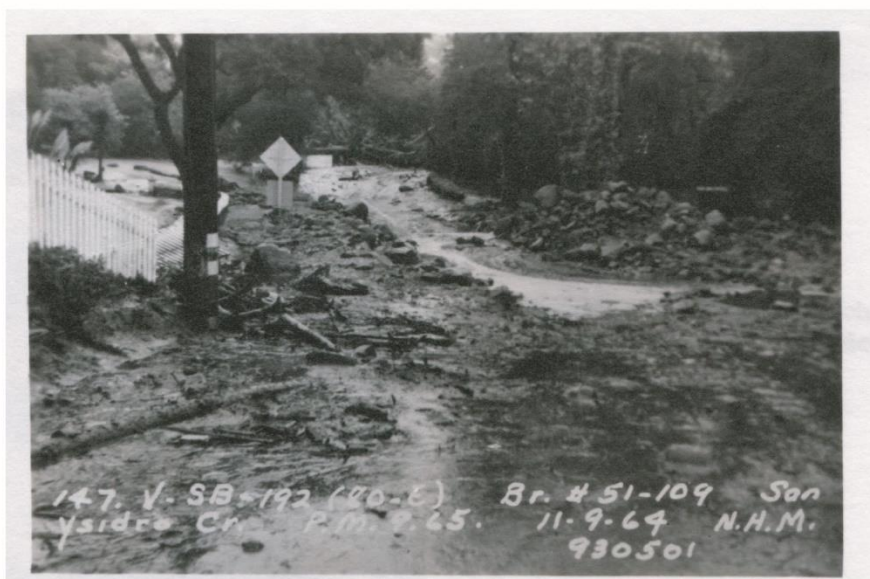
Figure 31B. View looking east along Highway 192 towards the bridge crossing on San Ysidro Creek. A portion of the debris had been removed but much remains to be cleaned up.

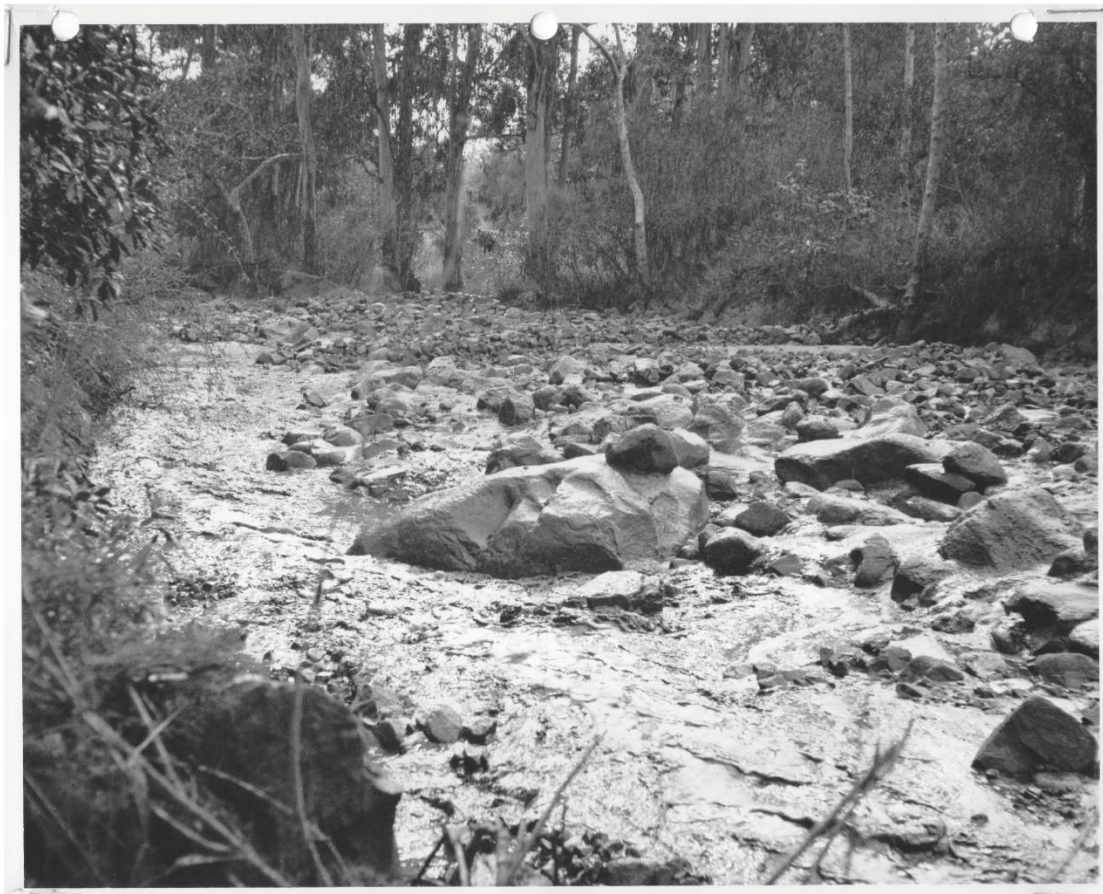
View of San Ysidro Creek looking upstream from the bridge crossing on Highway 192. The creek channel was filled in with debris and mud. Filling of the creek with debris and mud increases the potential for out-of-bank flows and direct impacts of debris to homes. Photograph courtesy of the Montecito Association of History Committee.

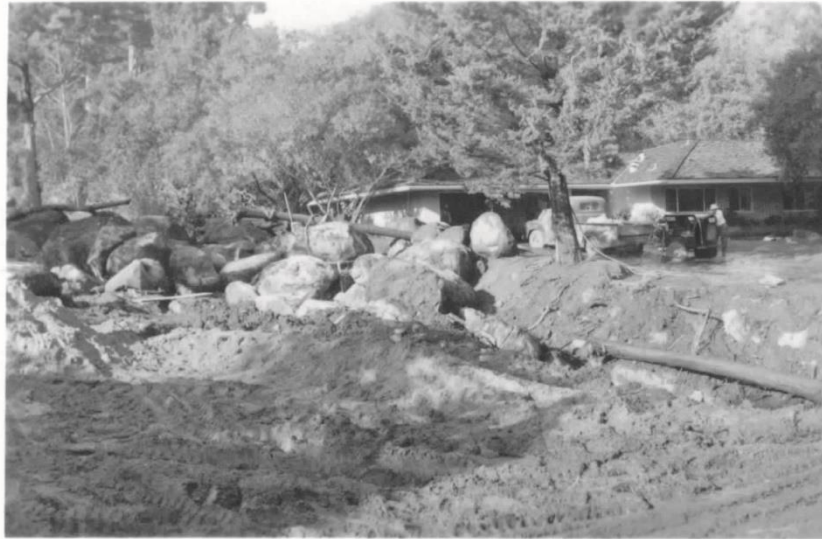
Figure 33A. Photograph looking northeast at the removal of debris from the creek channel of San Ysidro Creek at Highway 192. County of Santa Barbara (1964) estimated that 15,000 cubic yards of debris was removed from the channel for a length of several hundred feet.

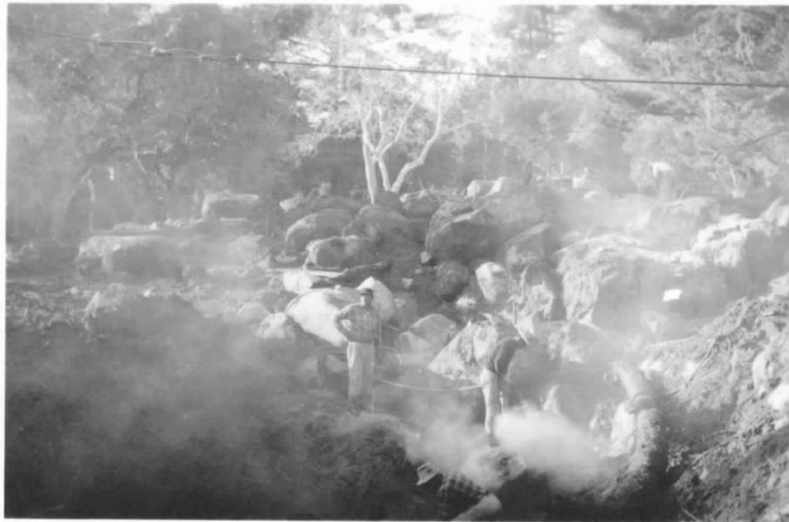
Figure 33B. Similar to the debris removal of the 1-9 event, large boulders required drilling and blasting to be removed from the San Ysidro Creek channel.

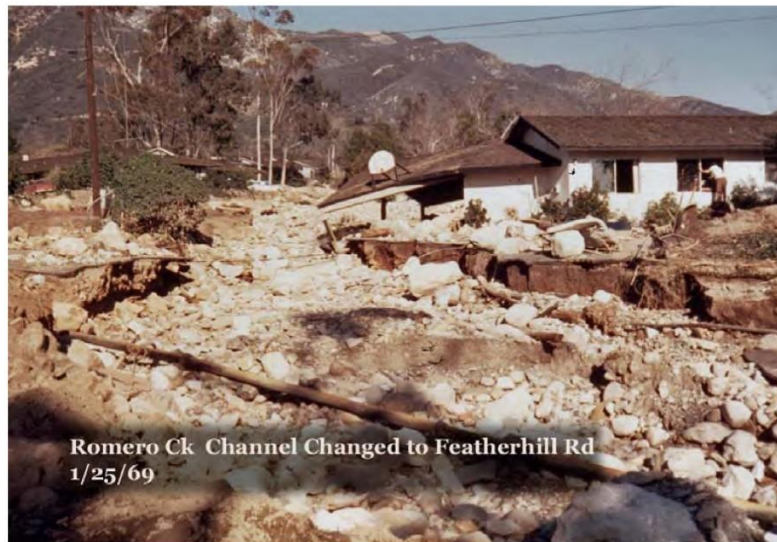
Figure 35A. New channel courses result often in Montecito due to plugging and filling with debris and mud. The flow from Romero Creek was diverted down Featherhill Road on January 25, 1969.

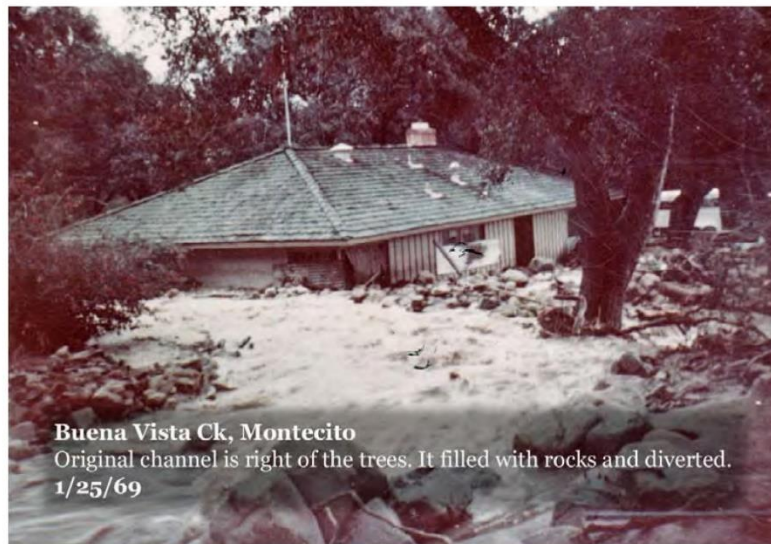
Figure 35B. The channel of Buena Vista Creek is filled with boulder debris and located just out of the photograph on the right-side. The debris flows were diverted around and through the residence on January 25, 1969.

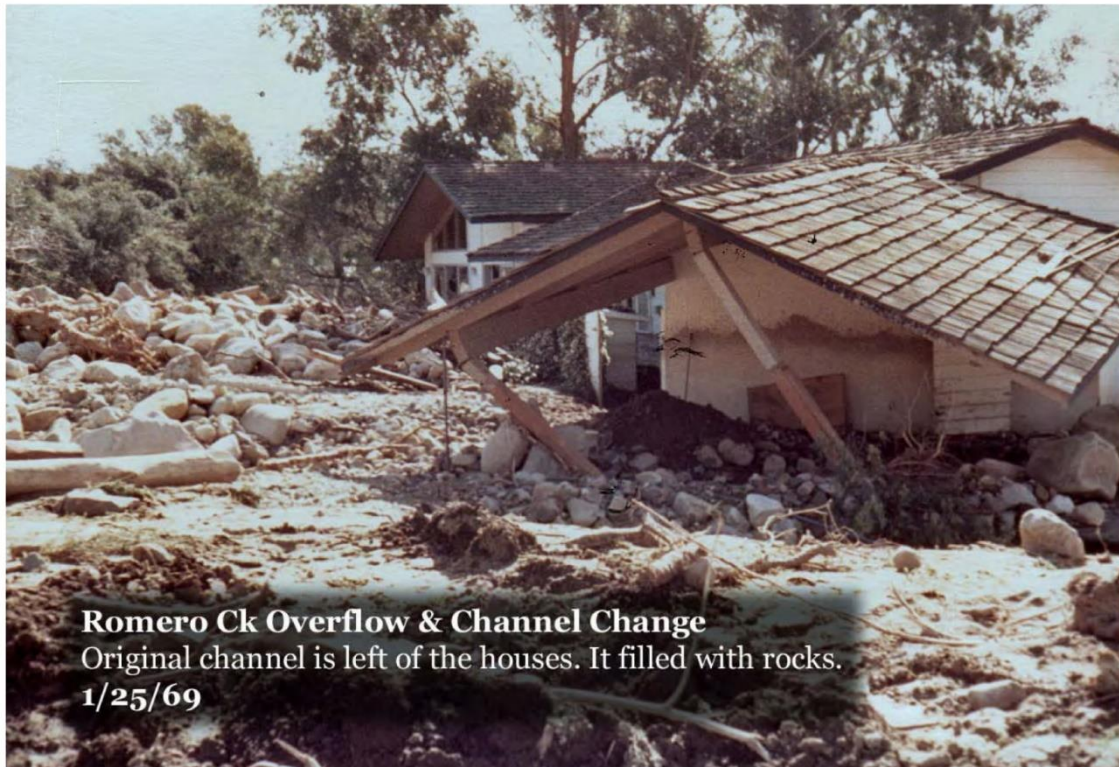
Vast amounts of boulder and tree debris were discharged from the watersheds creating much damage and destruction. in the 1969 event. The channel of Romero Creek filled with debris on January 25, 1969 causing out-of-channel flows which permits direct impacts of this debris with residential homes.

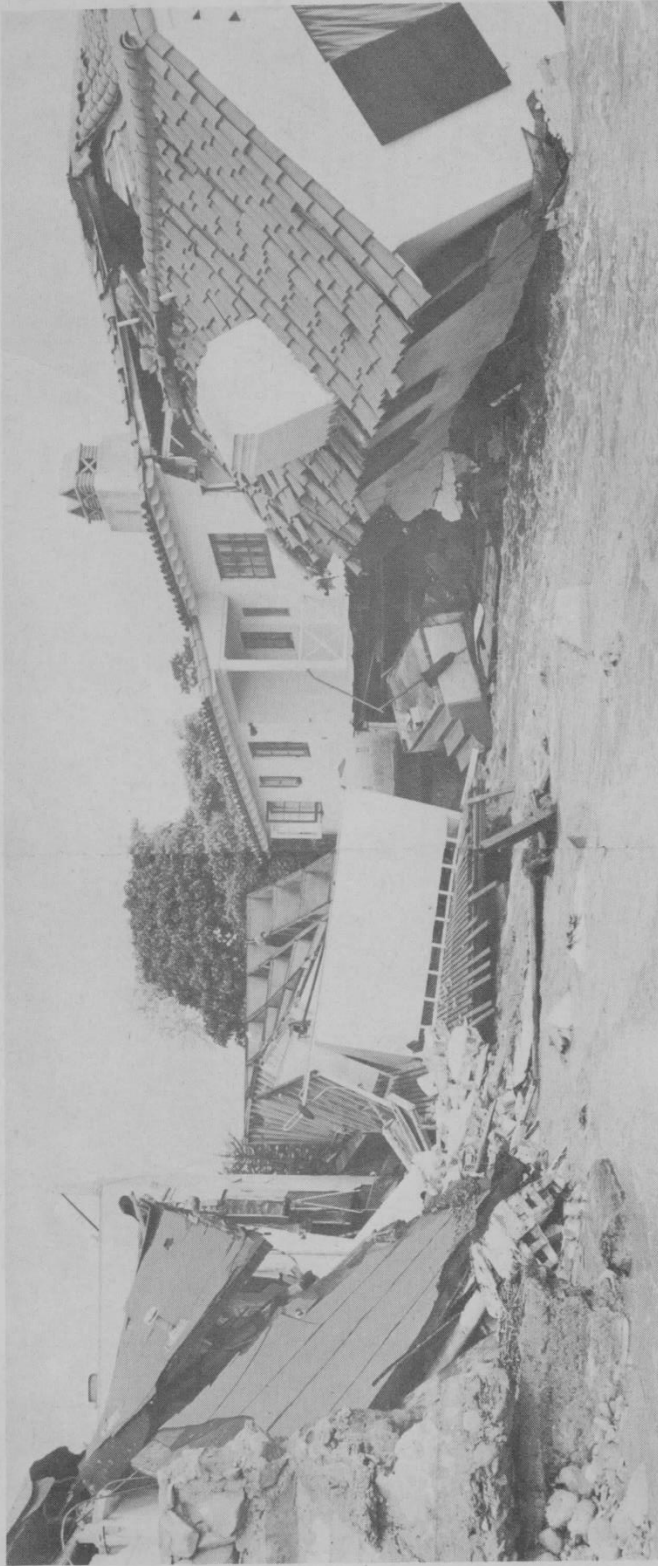
Development that encroaches a creek channel as in this case, and builds out over the channel of Montecito Creek, are at extreme risk for flood hazards. Erosion of the channel banks at the mouth of San Ysidro Creek undermined the foundations of these beachfront properties resulting in collapse of the structures into the creek channel. A bathhouse once extended from one of the homes over the channel but was ultimately destroyed.

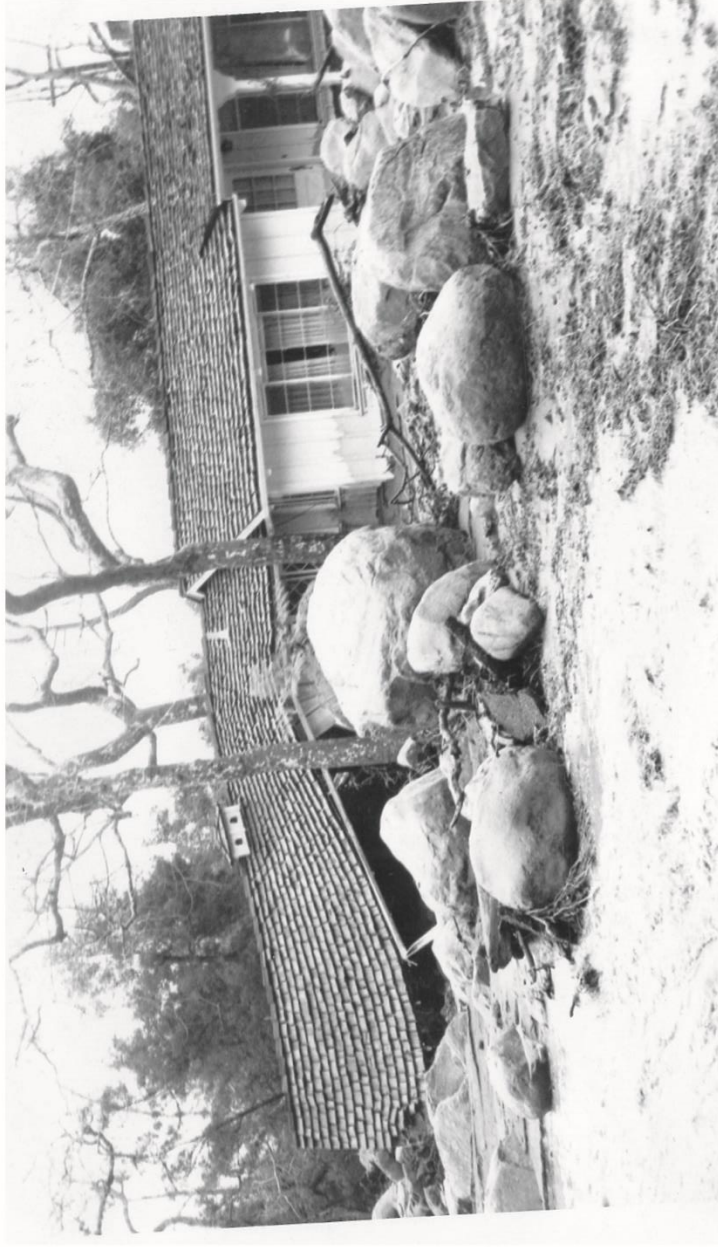
Huge boulders remain after out-of-bank flows from San Ysidro Creek inundate the Glen Oaks area. Photograph courtesy of the Montecito Association History Committee.

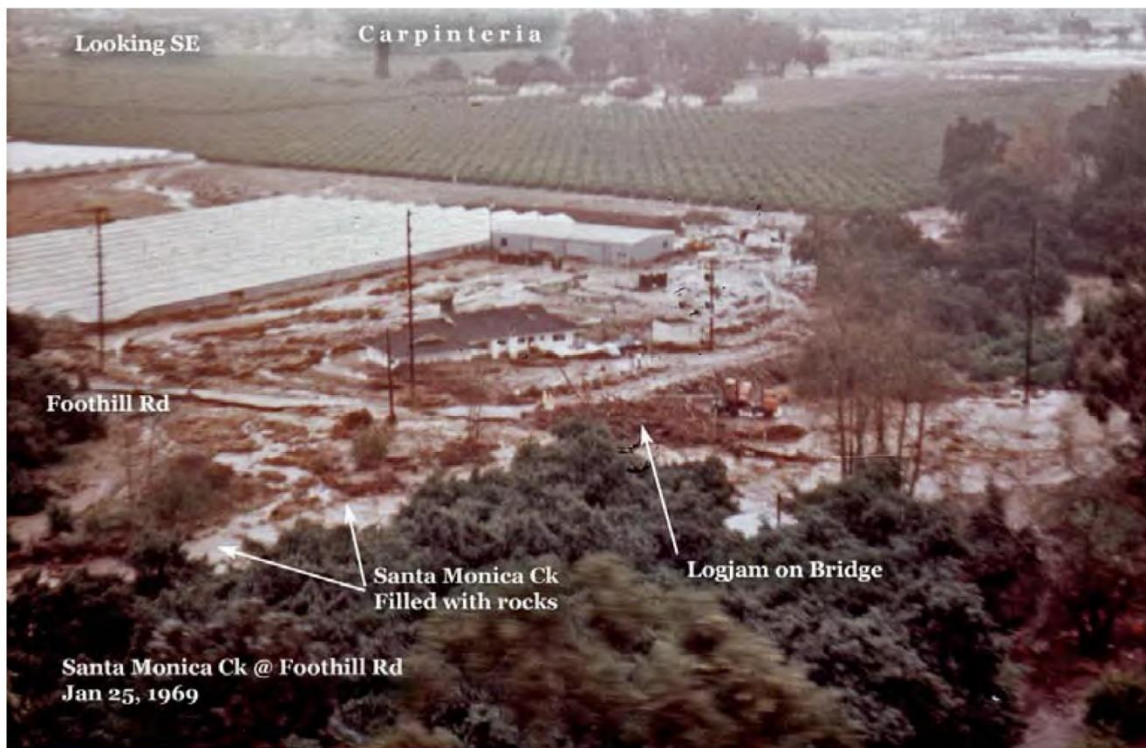
High debris production from Santa Monica Canyon in Carpinteria plugged the bridge on Highway 192 causing diversion of flow eastward into Franklin Creek about 2/3 of a mile away and also westward around the plug. Note the large vegetative debris pile in the center of the photograph.

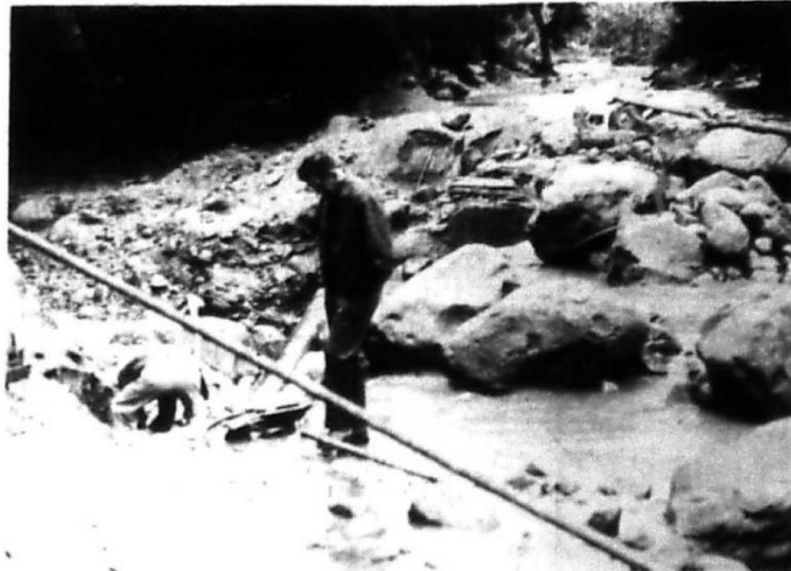
THIS IS where the Torito road bridge was. A gas company worker was out repairing the broken line at 7:30 a.m.

Boulders remain on the roadway and debris fills the channel of Toro Creek where the Torito road bridge was destroyed by debris flows.

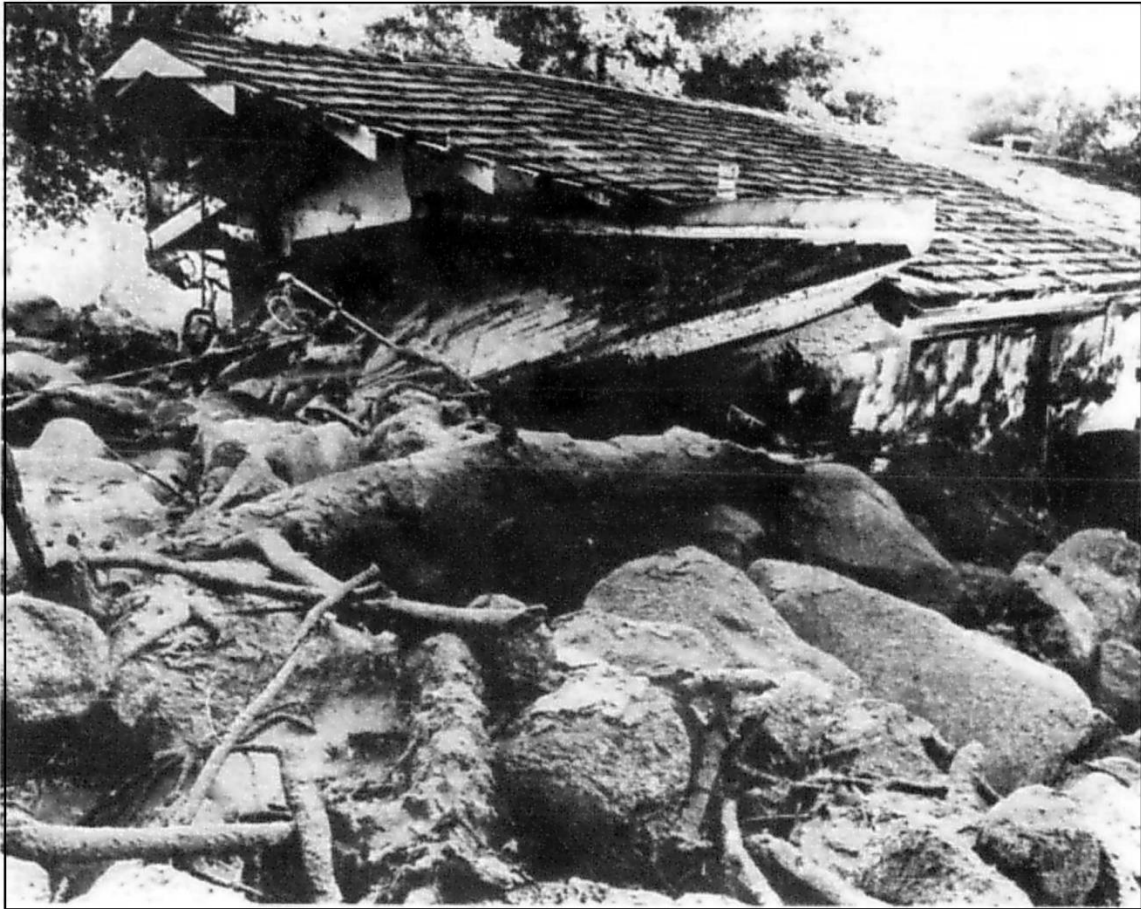
A home near the Toro Creek bridge on East Valley Road was severely damaged by debris flows on December 27, 1971. The occupants were rescued unharmed by first responders.

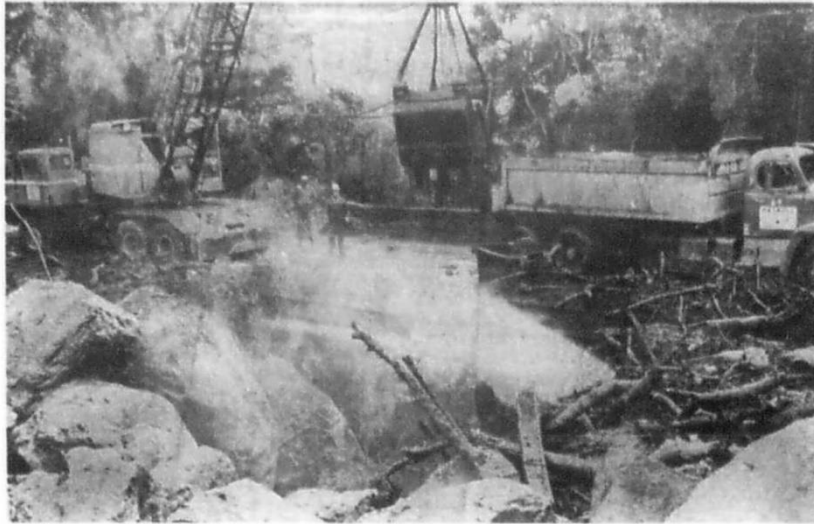
Figure 42.

Massive boulders and log debris are removed from the blockage at the bridge overpass on East Valley Road at Toro Creek.

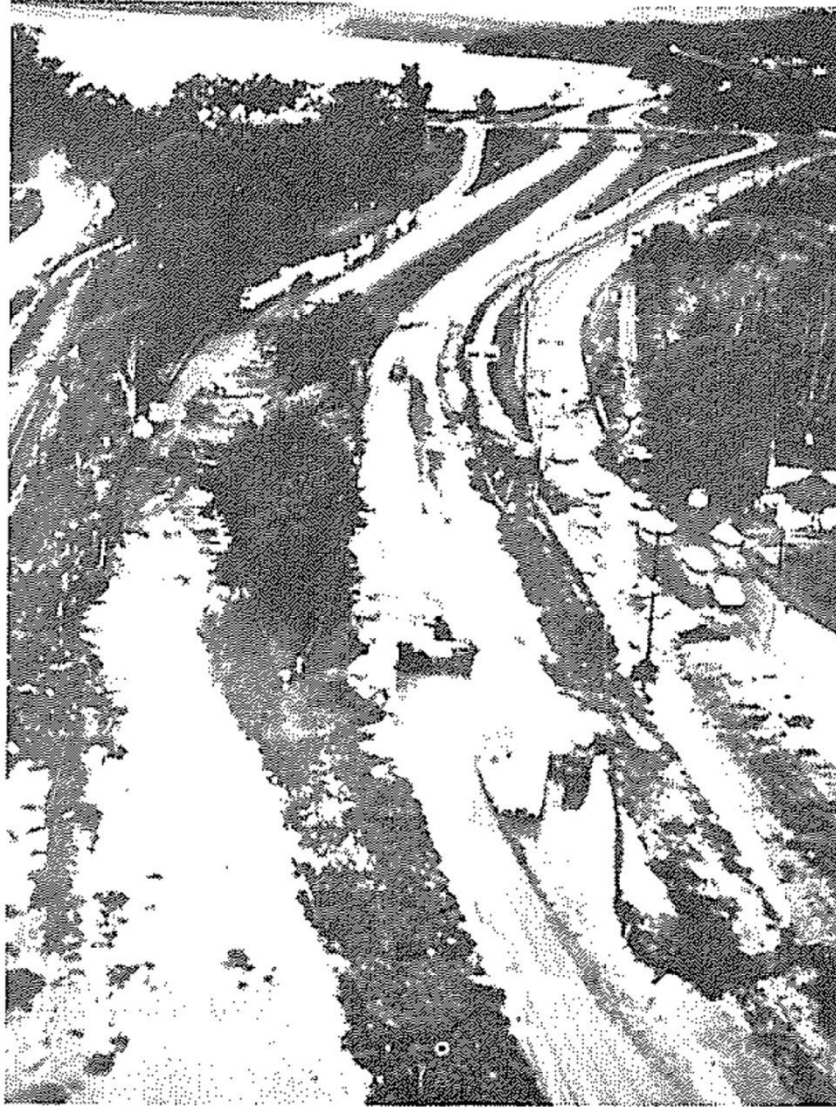
Highway 101 is inundated with mud and debris from Toro Creek. The Padaro Lane overpass is located near the top of the photograph

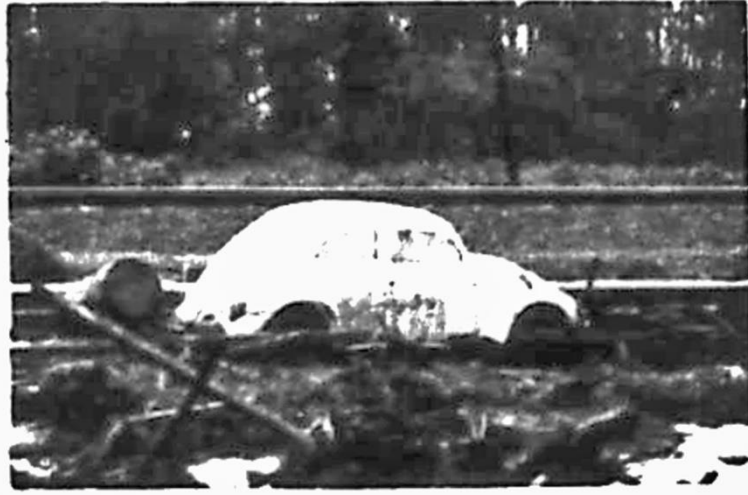
Figure 45.

This vehicle is turned the wrong way after encountering debris and mud that inundated both sides of Highway 101.

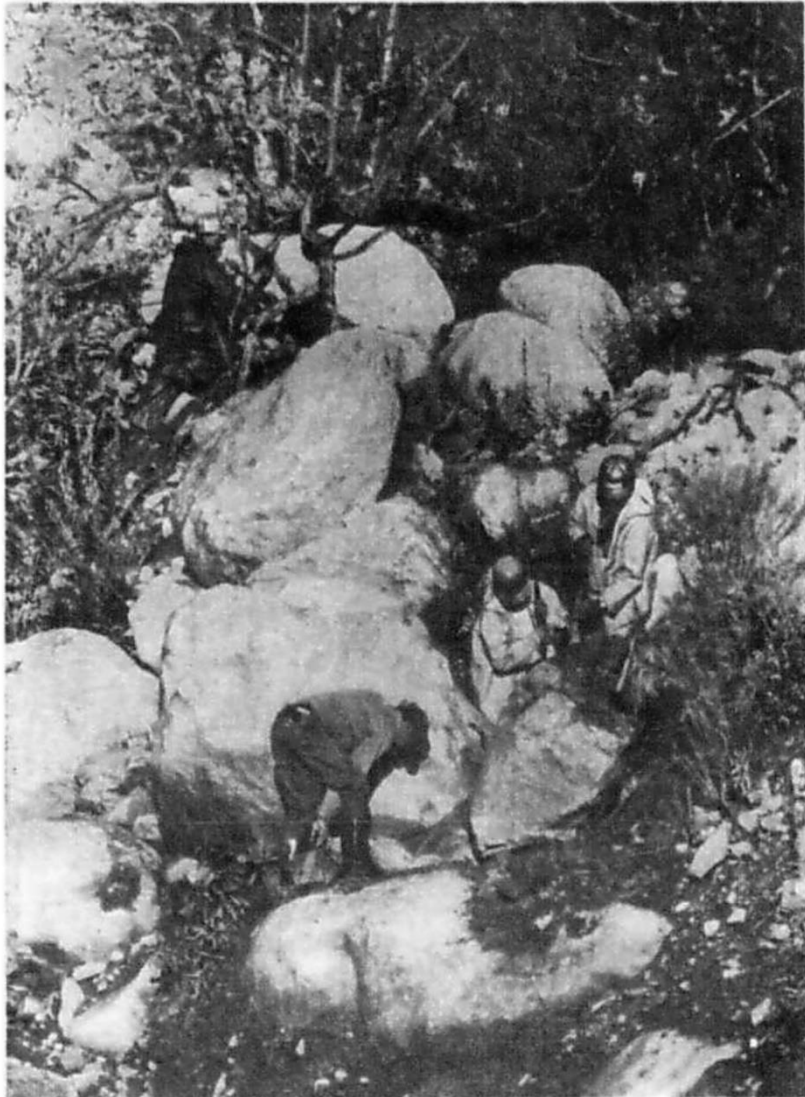
Large boulders are in the process of removal to clear Romero Creek after debris flows filled the creek channel with debris.

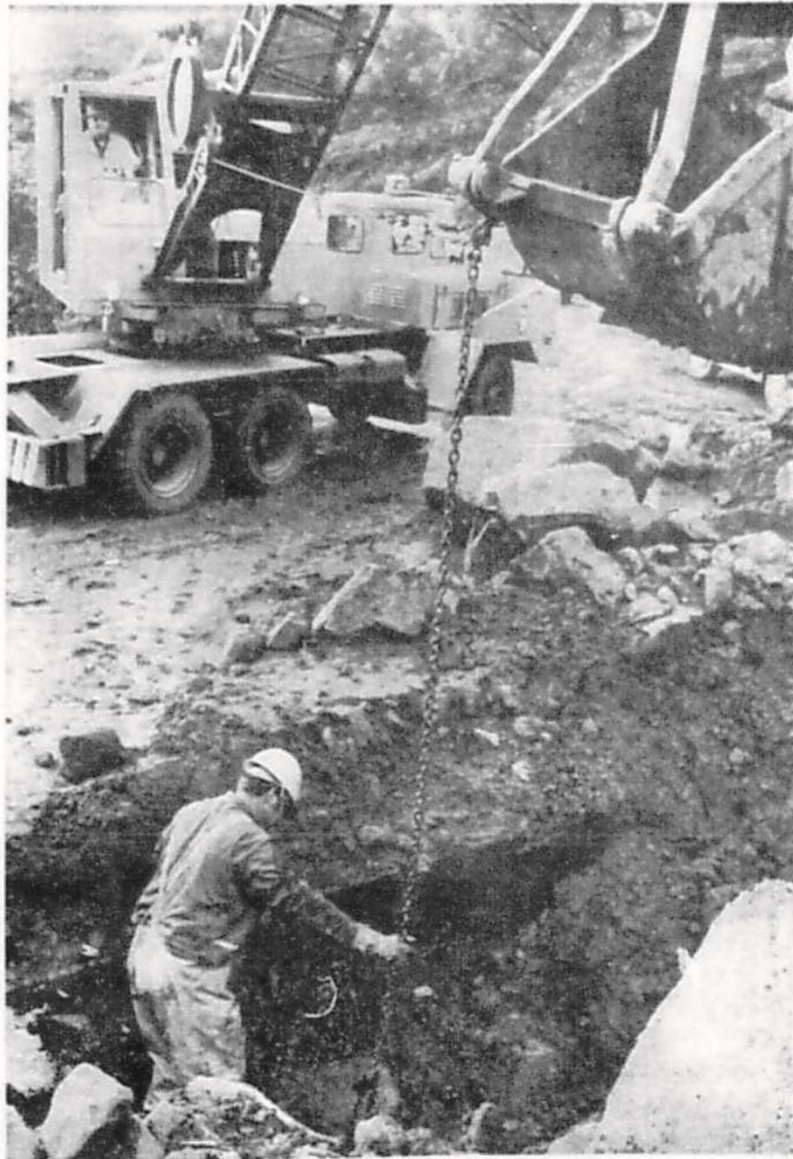
The plugged culvert under Buena Vista Road on Romero Creek is being cleared of debris .

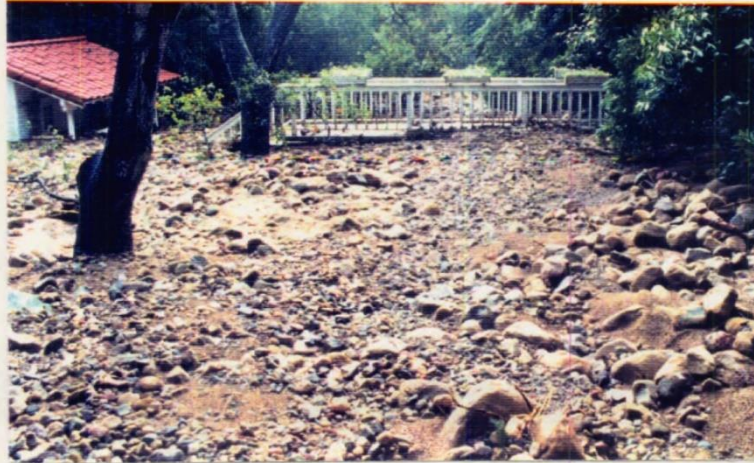
BUENA VISTA CREEK (E. Branch). Jan. 12, 1995.
Upstream of E. Valley Rd. Creek filled with rock.
Montecito.

Debris laden floods discharge vast amounts of debris from the watersheds above Montecito. Deposition and filling of creek channels is one of the consequences of debris floods that produce out-of-channel flows, when directly impacts homes with boulder and vegetative debris.

Debris plugging culverts was a major problem in addition to the filling of creek beds, both of which resulted in out-of-channel flows that diverted debris onto roads and flooding of homes (Plate 3; Figure 48) (Santa Barbara County Flood Control, 1995). The east branch of Buena Vista Creek completely filled in with debris upstream of plugged culvert on East Valley Drive and East Mountain Drive (Figure 49). Diversion of flows from Montecito Creek down Olive Mill Road inundated the homes along Danielson Road, Virginia Roak, and Virginia Lane, east of Olive Mill Road (Plate 3). Overflows from Oak Creek entered San Ysidro Creek exacerbating flooding along it and inundated Highway 101. Flooding also occurred on Romero Creek in the area below Highway 101 (Santa Barbara County Flood Control, 1995). Highway 101 was also inundated with mud and debris from Arroyo Paredon Creek west of Carpinteria.

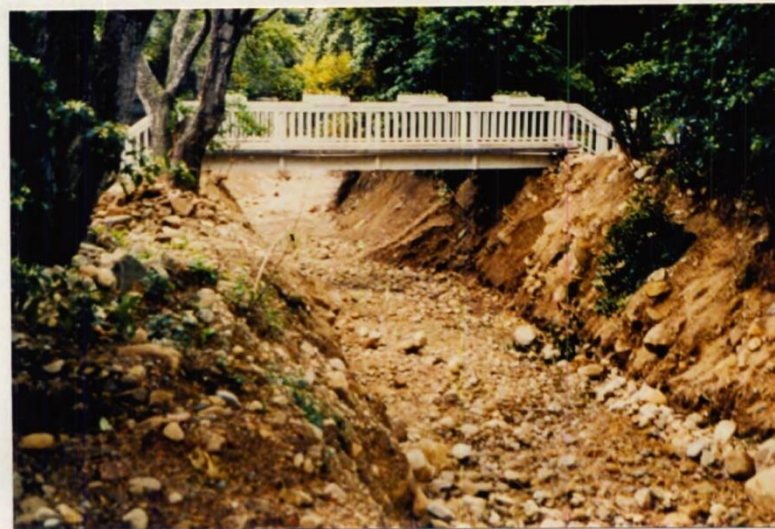
BUENA VISTA CREEK (E. Branch). Feb. 21, 1995.
Upstream of E. Valley Rd. Creek restored after
removal of rock. Montecito.

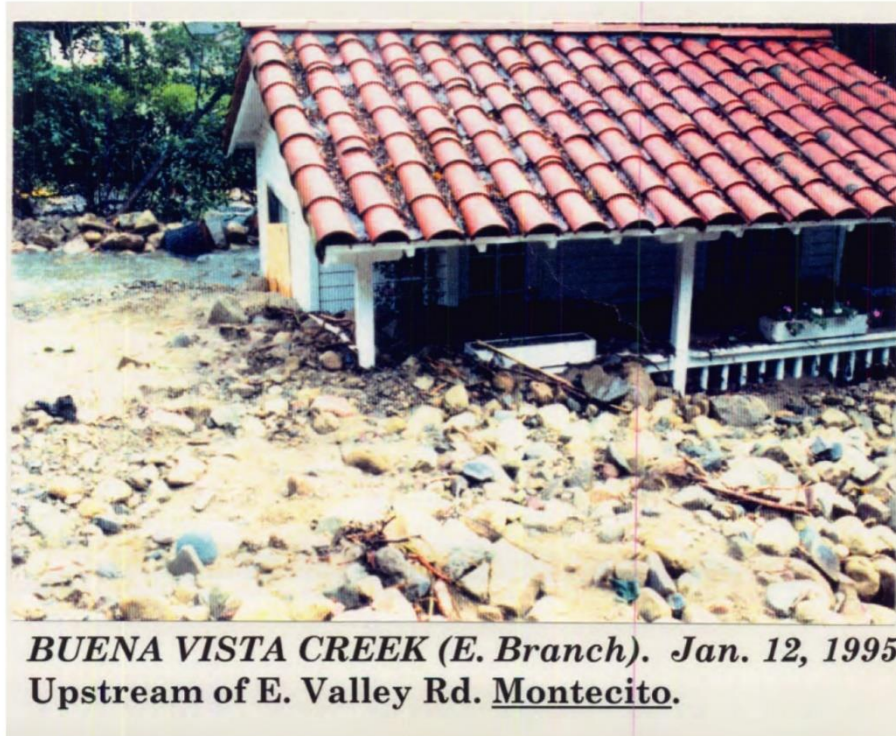
Figure 49.

Boulder debris impacted home near the east branch of Buena Vista Creek after the first debris laden flood event.

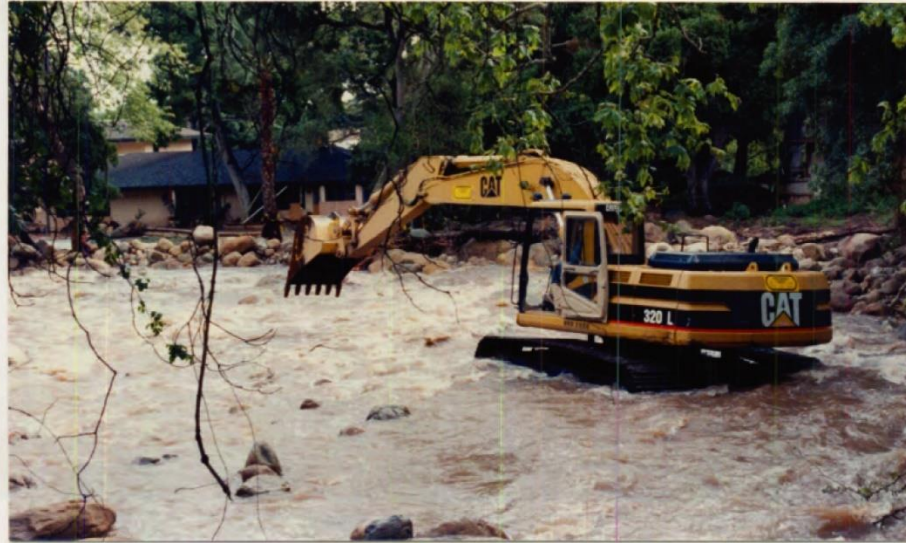
MONTECITO CREEK. Mar. 11, 1995. Downstream of Olive Mill Rd. Removal of rock, boulders which filled in creek. Montecito.

Boulder debris filled in the channel of Montecito Creek in the second debris laden flood event creating out-of-channel flows.

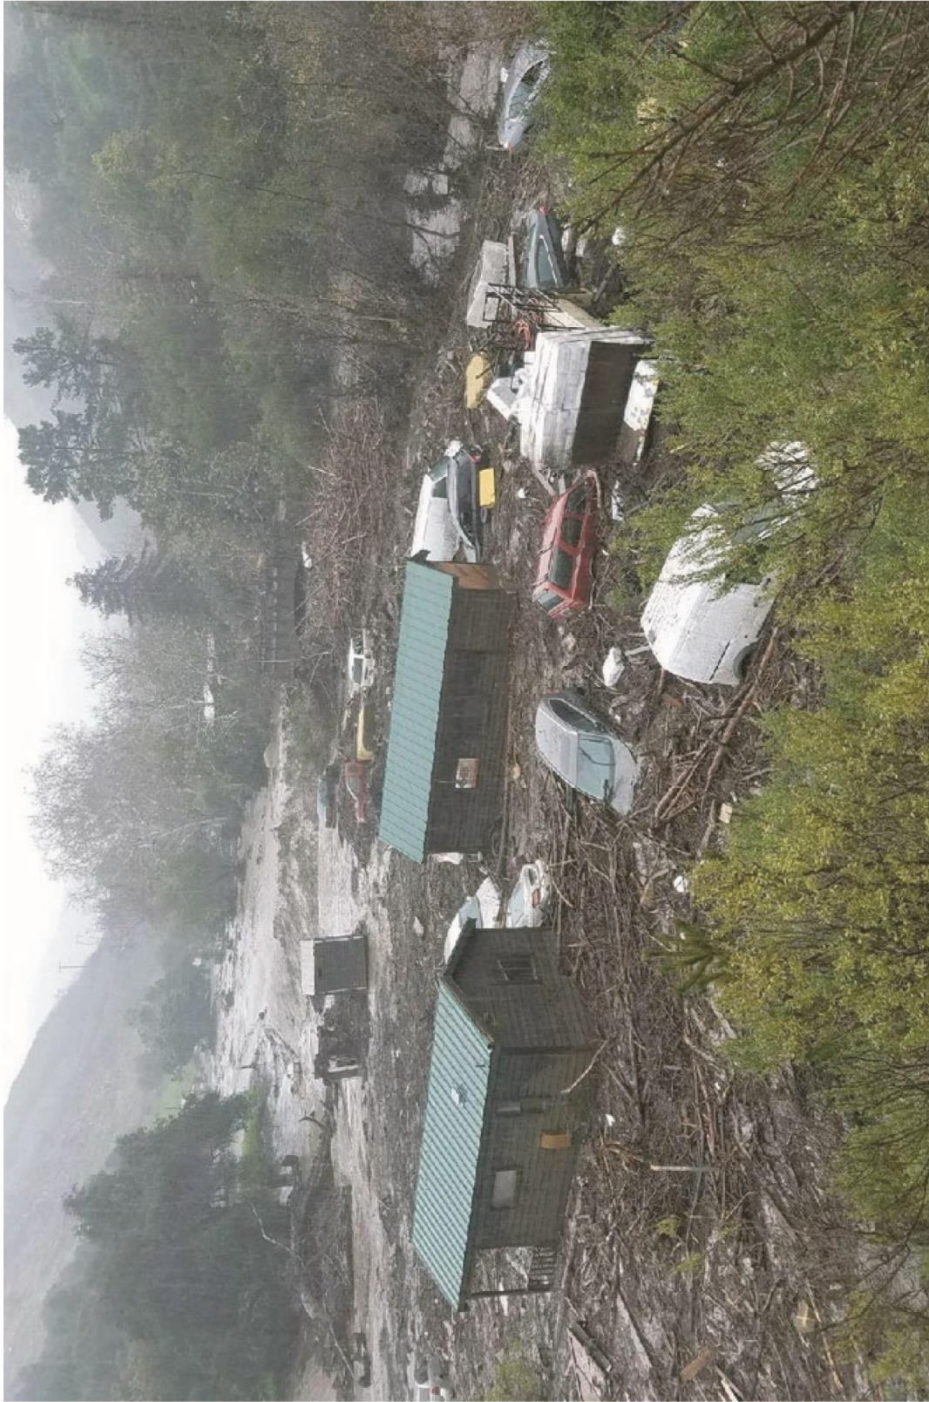
Debris flows choked with vegetative debris, automobiles, and cabins accumulate upstream of a plugged culvert under Highway 101. Photograph courtesy of managing editor, Giana Magnoli and Noozhawk (noozhawk.com). Figure 51.

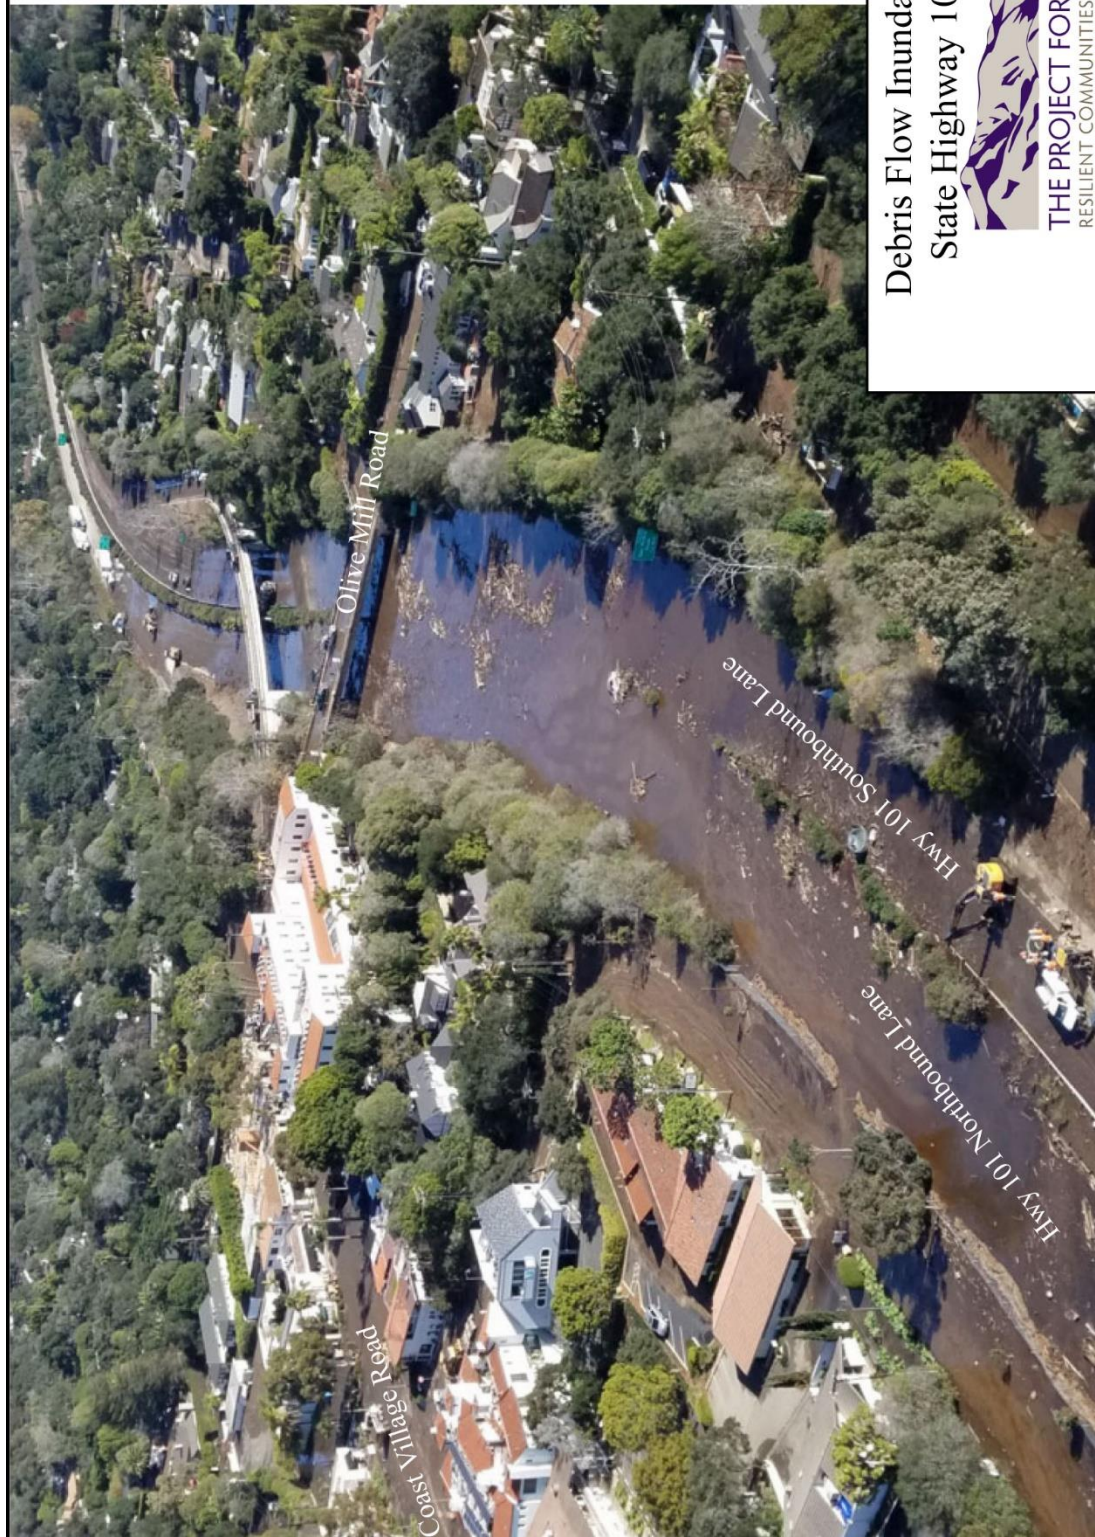
Figure 52.

Aerial photograph of the debris flow inundation of State Highway 101 in the vicinity of the Olive Mill Road overpass on January 9, 2018. Debris, mud, and other debris incorporated into the flows are retained in the highway corridor where the road elevation is lower than the surrounding areas. The highway was closed for thirteen days, the time it took to remove the debris and repair the highway and resulted in economic losses to the local business community and statewide. Photograph courtesy of Noozhawk photograph, January 9, 2018. Photograph credit: California Highway Patrol.

Entrainment of debris not only occurs in creek channels upstream of the canyon mouths, but it also occurs on the upper fan and through confined channels in the Mission Ridge Fault Zone, with some deposition due to constrictions and blockages with infrastructure, homes, and oak trees (Plate 3). Flows on the lower fan tend to spread laterally due to reduction in channel and fan gradients, and accumulates in depressions such as Highway 101 which acts like a debris basin (Figure 52).

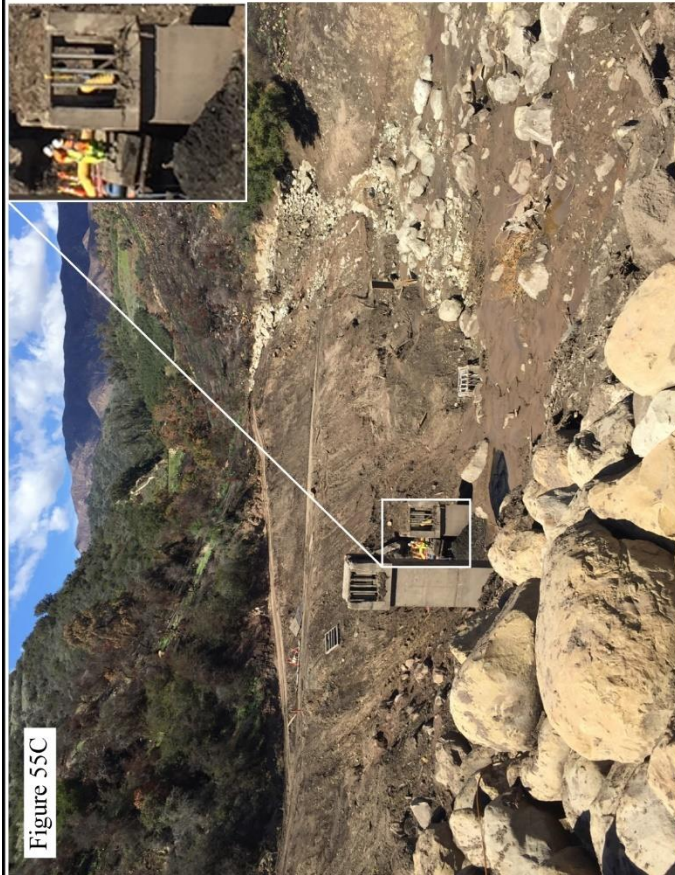
Figure 55A (upper left). View of the Santa Monica debris basin filled with mud, boulder, and vegetative debris after the 1-9 debris flows. An upstream bridge is buried in the muck and mud and vegetative debris choke the spillway in the lower left of the image. Google Earth aerial image dated January 12, 2018. Figure 55B (lower left). View of vast amounts of vegetative debris discharged out of Santa Monica Canyon and captured by the debris basin. Figure 55C (upper right and inset). View of the empty basin on March 15, 2018. Note that the two intake valves were completely buried in the muck (see inset image). Photographs provided by Maureen Spencer of the County of Santa Barbara Flood Control District.

A prime example of the reduction of hazards of debris flows and debris laden floods is the utilization of the Santa Monica debris basin on Santa Monica Creek in Carpinteria (Figure 55A, 55B, and 55C). County of Santa Barbara Flood Control manager, Tom Fayram, stated “*Santa Monica Debris Basin was the hero. It took the brunt of the storm*” (Noozhawk, February 20, 2018). He went on to state “*We avoided some horrific damage that would have certainly happened if we didn’t have this.*”

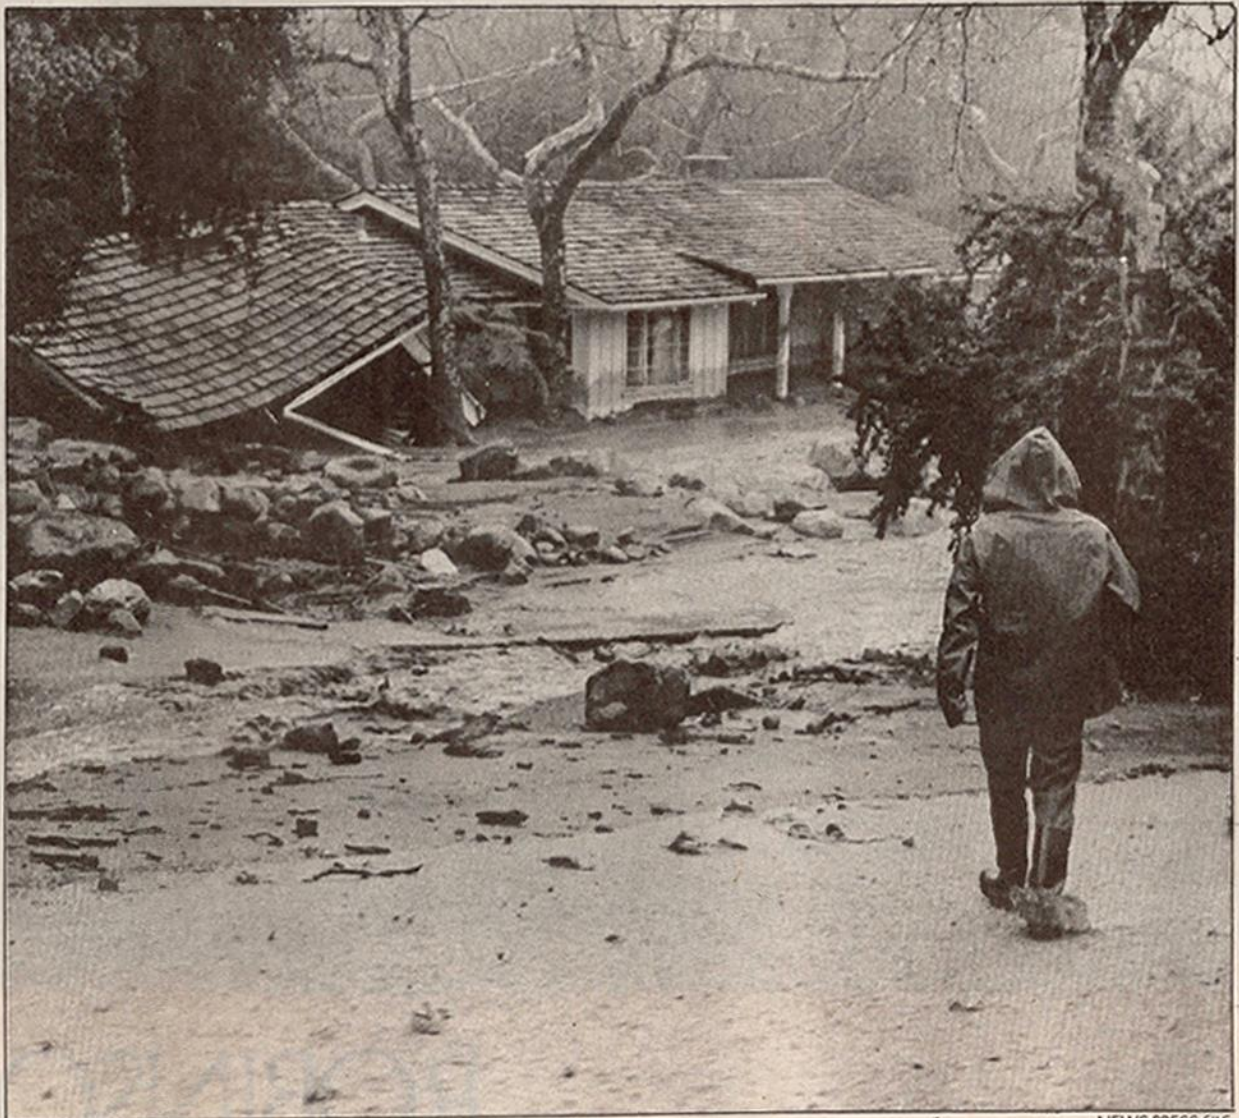
Floodwaters knocked supports out from under the carport at this home on San Ysidro Road in Montecito in 1969.

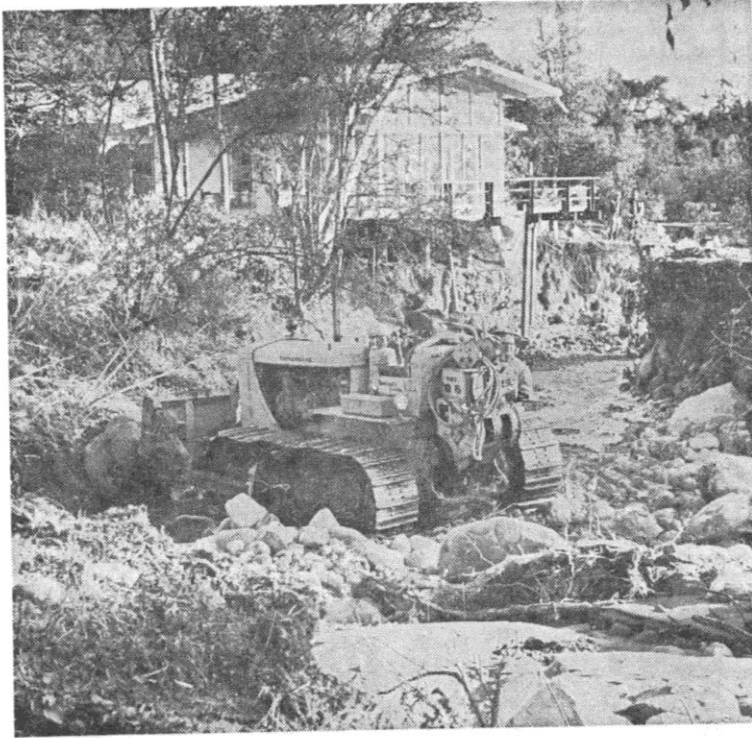
WITH DELIBERATE HASTE this bulldozer is diverting Toro Creek away from its devastating attacks against all that is left of the shored-up embankment that, before the storm, was about 15 feet away from the Michael O'Shaughnessy home on Torito Road.

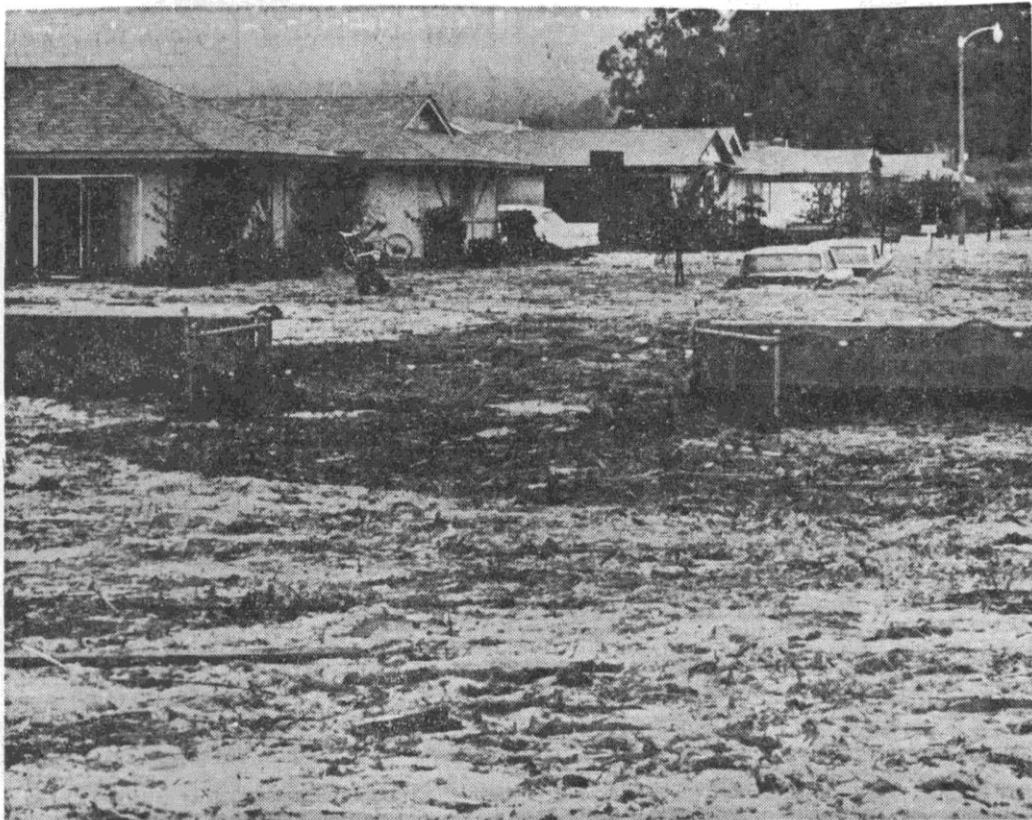
THIS WAS one of the scenes witnessed by motorists on Highway 101 yesterday in the Carpinteria Valley—muck and mire window deep in stalled cars, a youngster plowing through oozy mud after he unearthed his minibike.
—News-Press photo

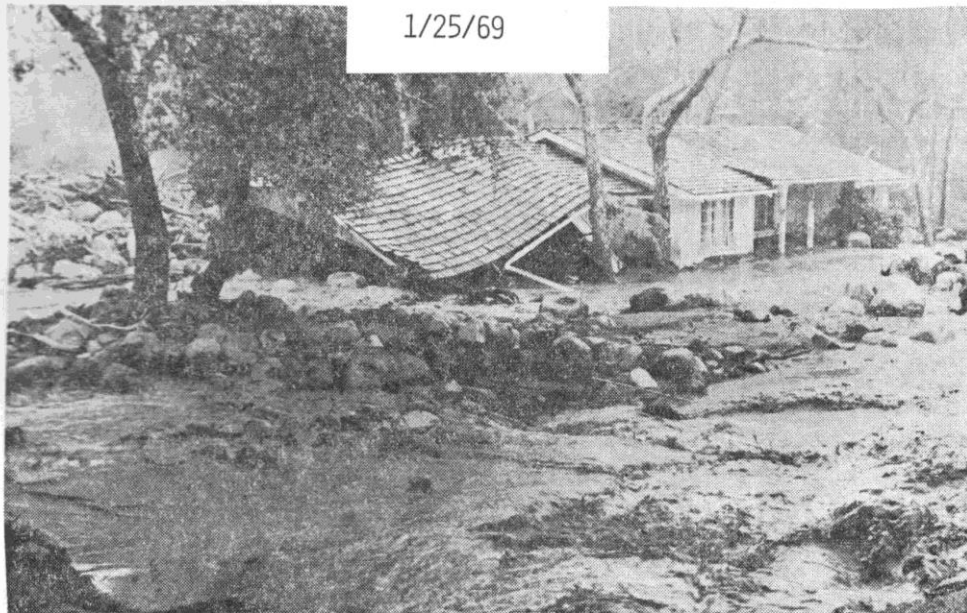
MUD AND WATER up to two feet deep on lovely carpeting, the supports knocked out from under the carport, filled now with boulders rolled down by the flooding San Ysidro Creek, this was the scene at 1790 Glen Oaks Dr. in Montecito, summer home of Kenneth Simpson of Pasadena.
