**FIRE, FLOOD, AND LANDSLIDE DAM HISTORY:
COMMUNITY OF MONTECITO AND VICINITY
SOUTHERN SANTA BARBARA COUNTY, CALIFORNIA**

THE PROJECT FOR
RESILIENT COMMUNITIES

LARRY D. GURROLA, Ph.D., P.G., C.E.G.

February 25, 2022

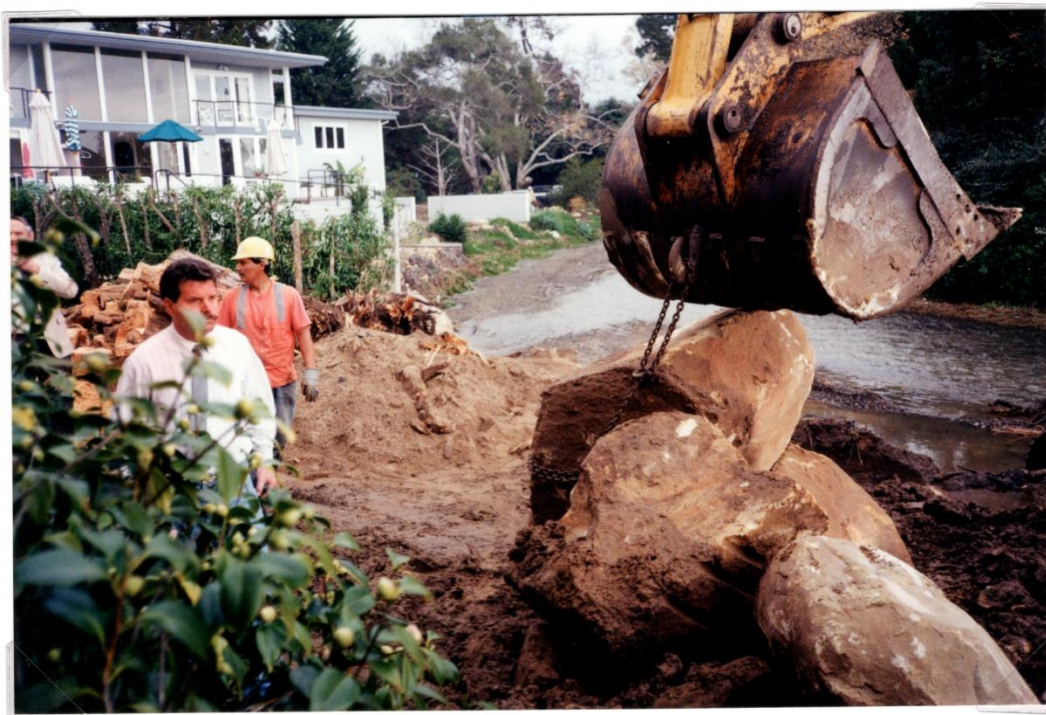
Clean up of debris at the mouth of San Ysidro Creek after debris laden floods in March 1995. Photographs from the Montecito Association History Committee.

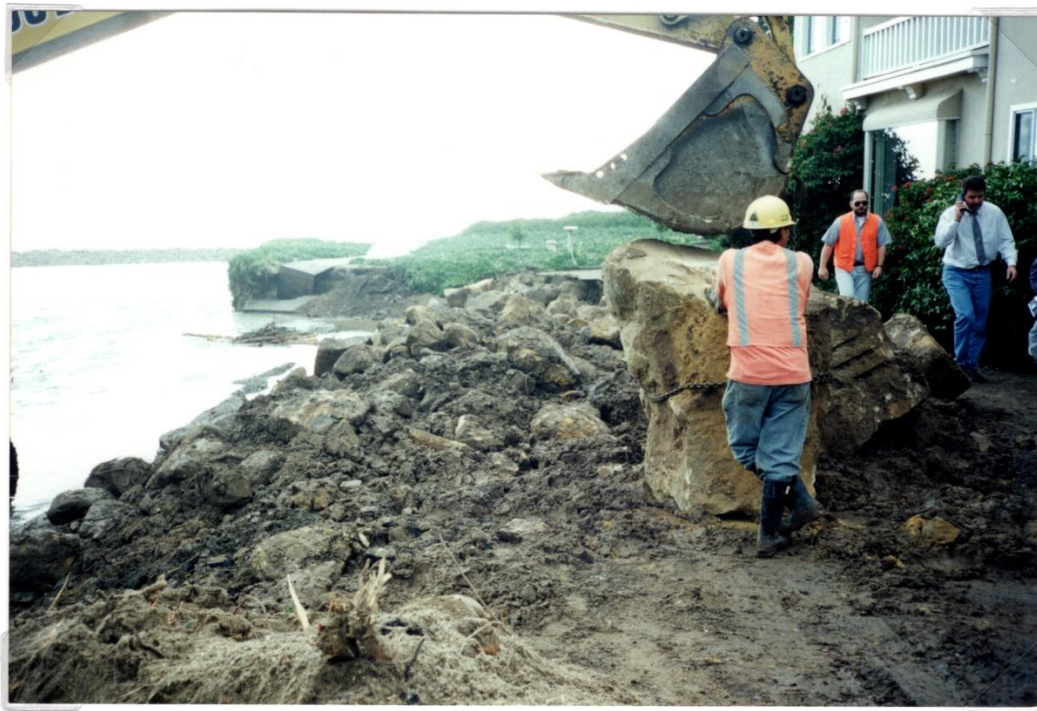
View to southwest at the mouth of San Ysidro Creek and some of the debris cleared from the channel. Photographs from the Montecito Association History Committee.

Boulder and vegetative debris.

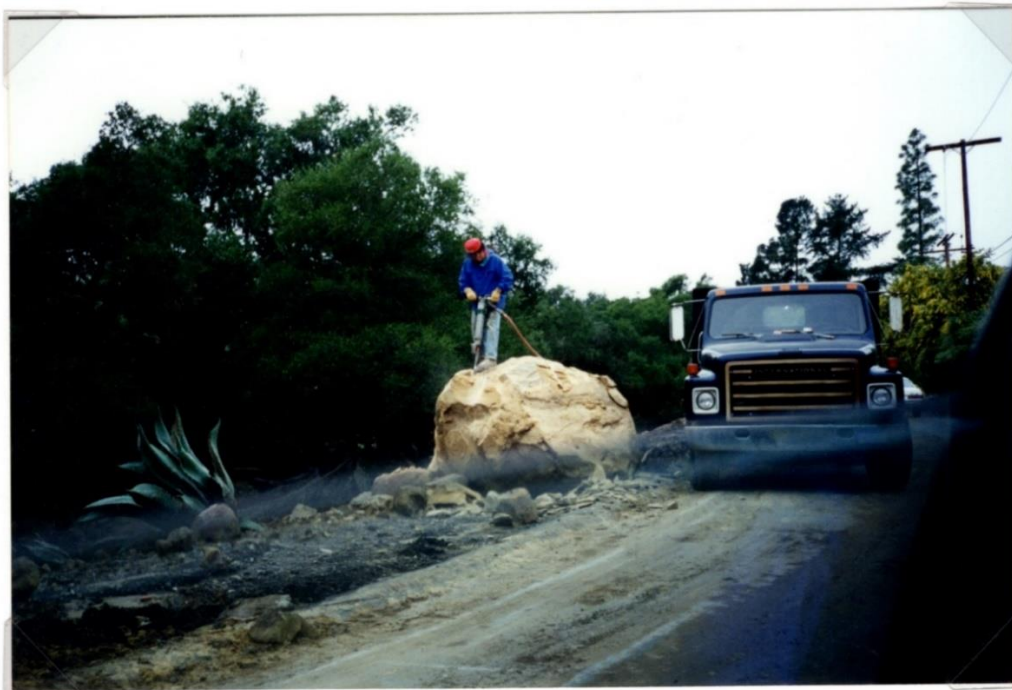
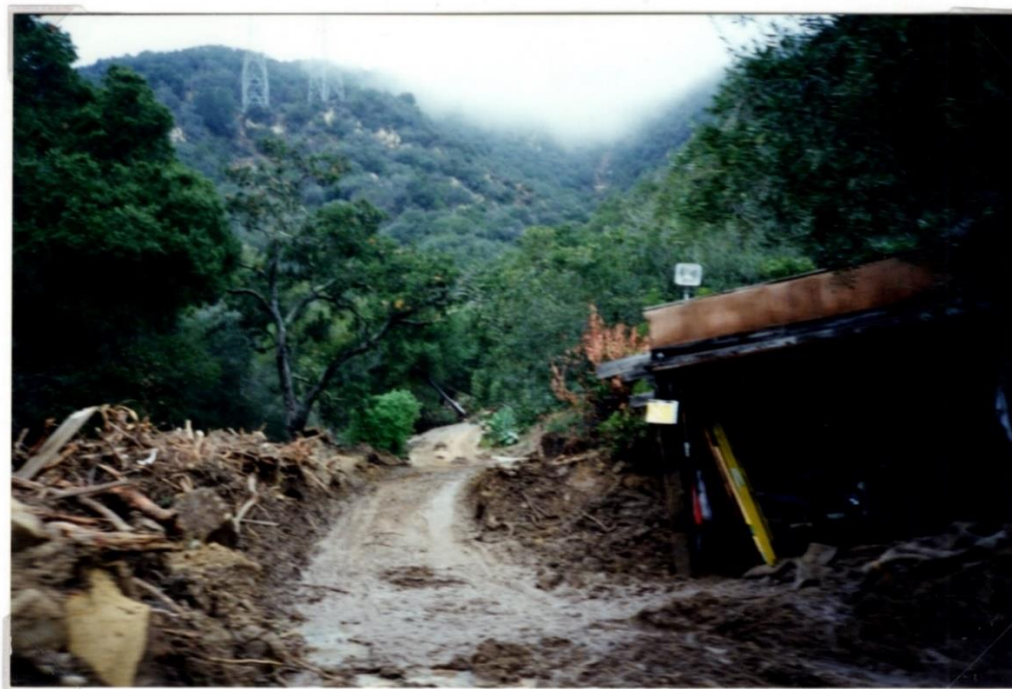
Upper photograph: A jackhammer whittles down a massive automobile size boulder on Mountain Drive. Lower photograph: Accumulated woody and rock debris on Mountain Drive in Montecito. Photographs from the Montecito Association History Committee.

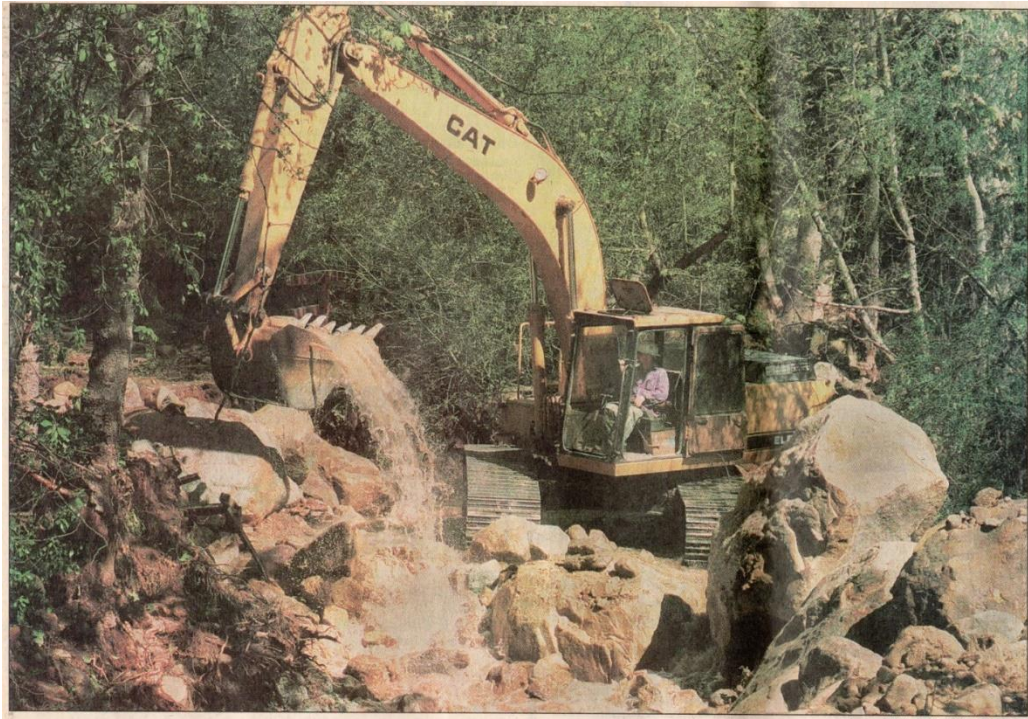
An excavator digs out boulders and other debris from Westmont Creek.

Santa Barbara News Press photograph (March 13, 1995) shows an excavator removing debris from Westmont Creek after the second debris flood event.

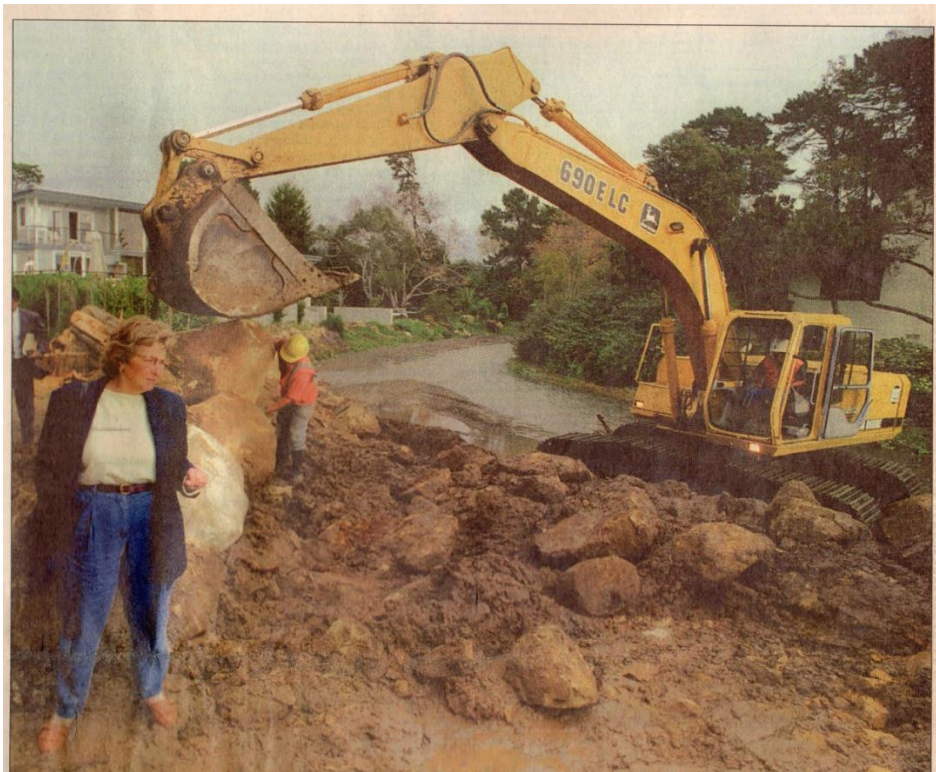
Santa Barbara News Press photograph of First District Supervisor Naomi Schwartz surveys damage to homes along Montecito Creek. Santa Barbara News Press March 13, 1995.

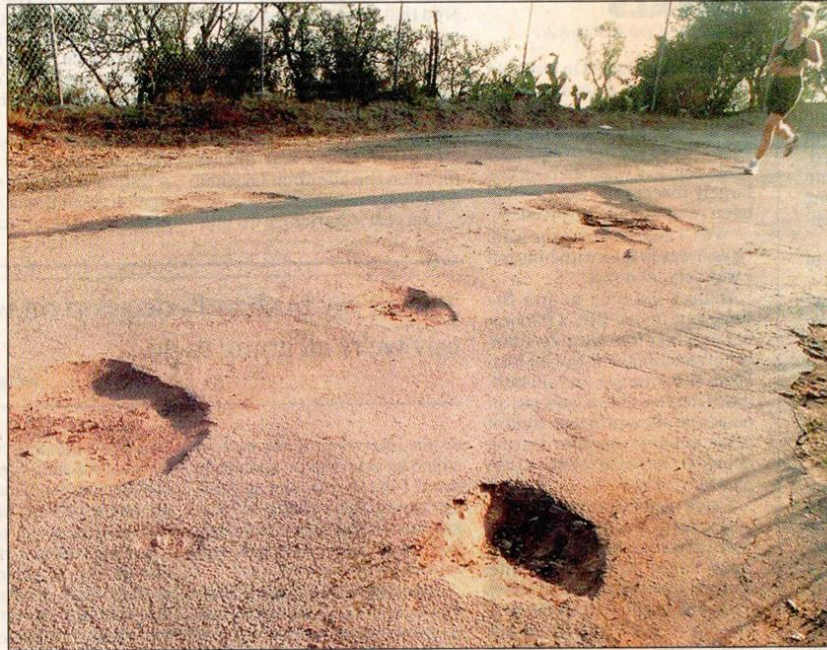
Mountain Drive above Montecito is one of the roadways still needing major storm-related repairs. Last winter's storms caused an estimated \$10 million in damage to county roads. Officials say less than half the repair work has been completed and there is no funding available to finish the job.

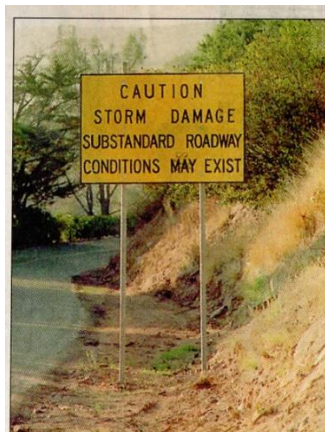
Hard-hit roads like Mountain Drive near Coyote Road have been repaired just enough to make them passable.

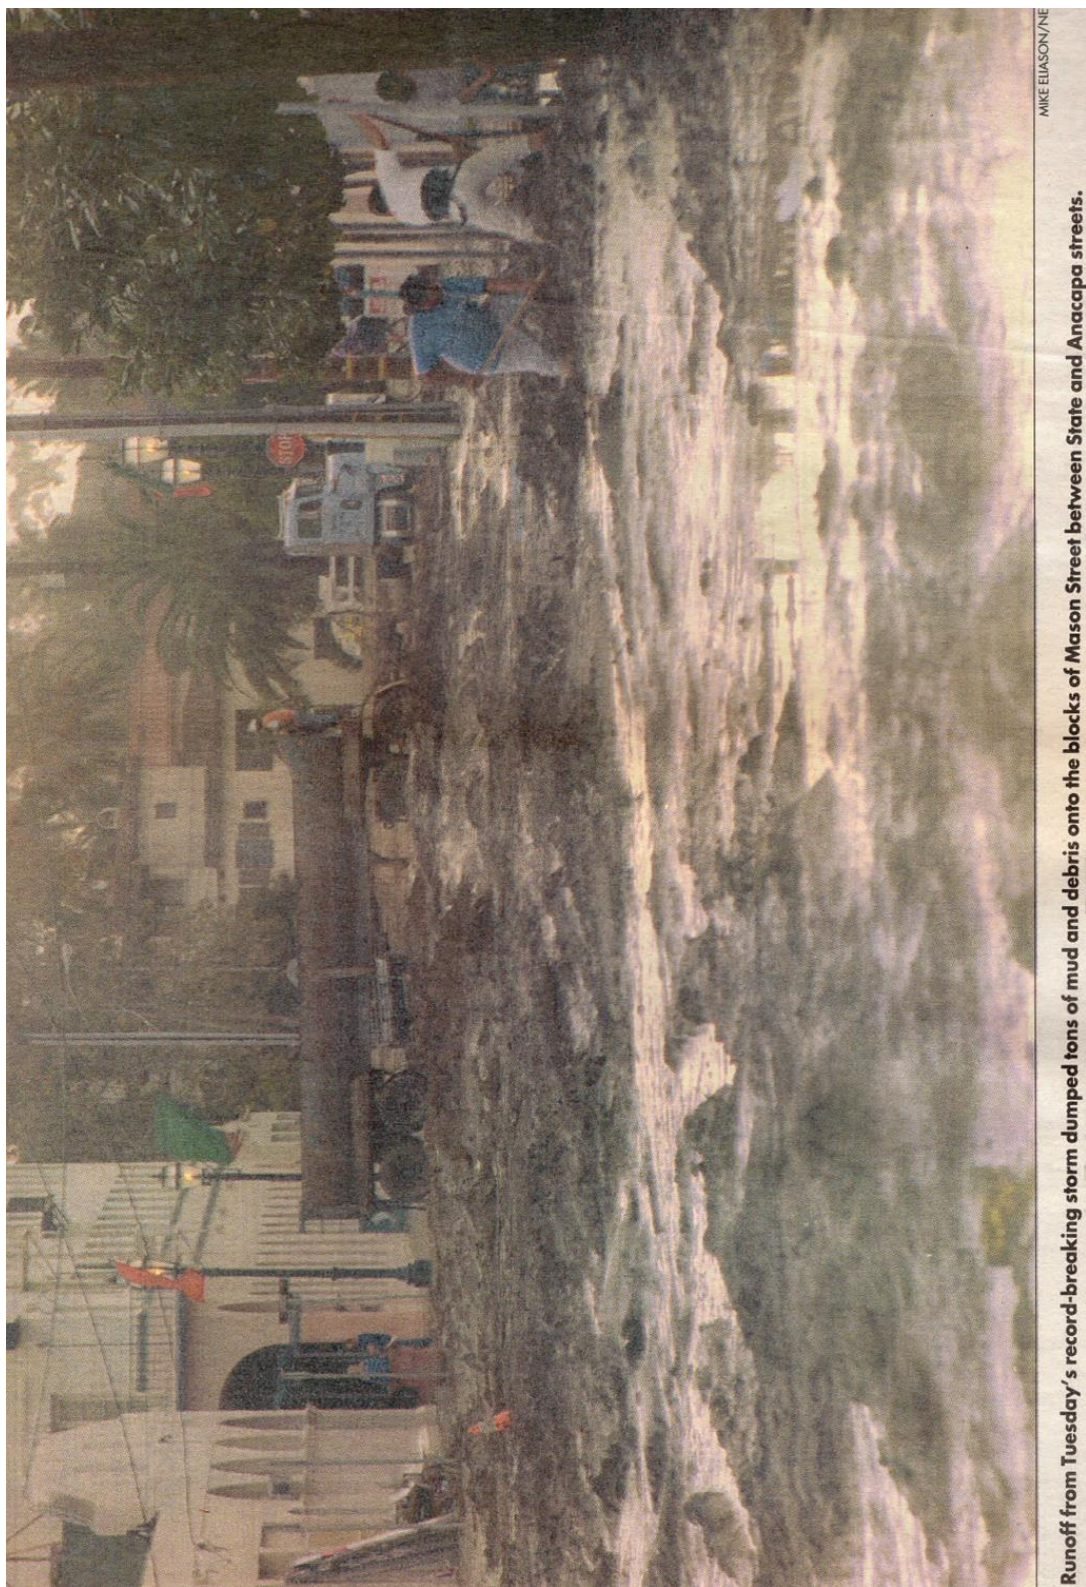
Runoff from Tuesday's record-breaking storm dumped tons of mud and debris onto the blocks of Mason Street between State and Anacapa streets.

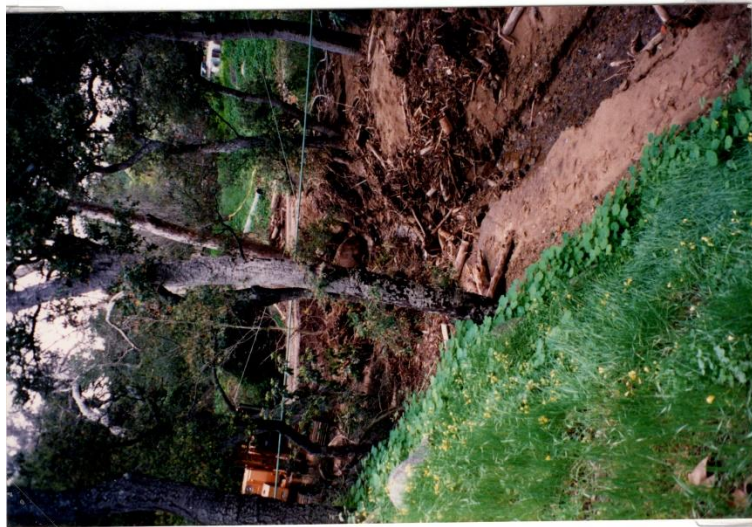
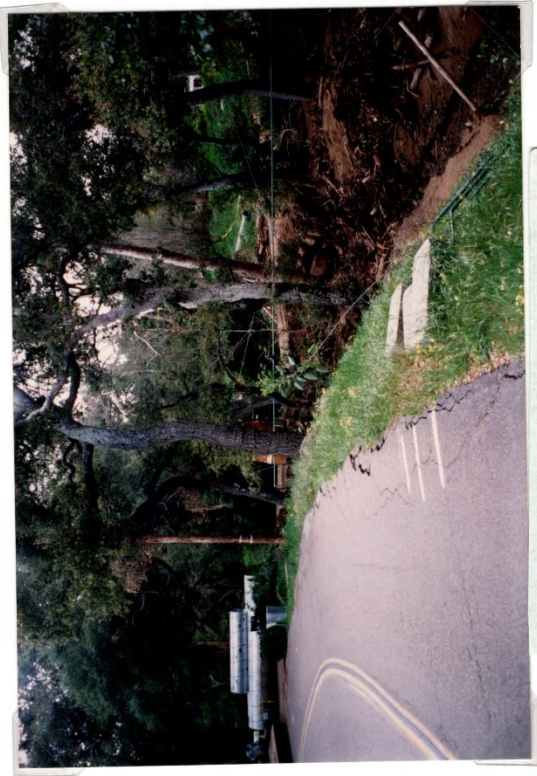
Flood damage from storm 1/10/95
Access road to 849 and 855 Ashley
Road over culvert destroyed, now
being repaired.

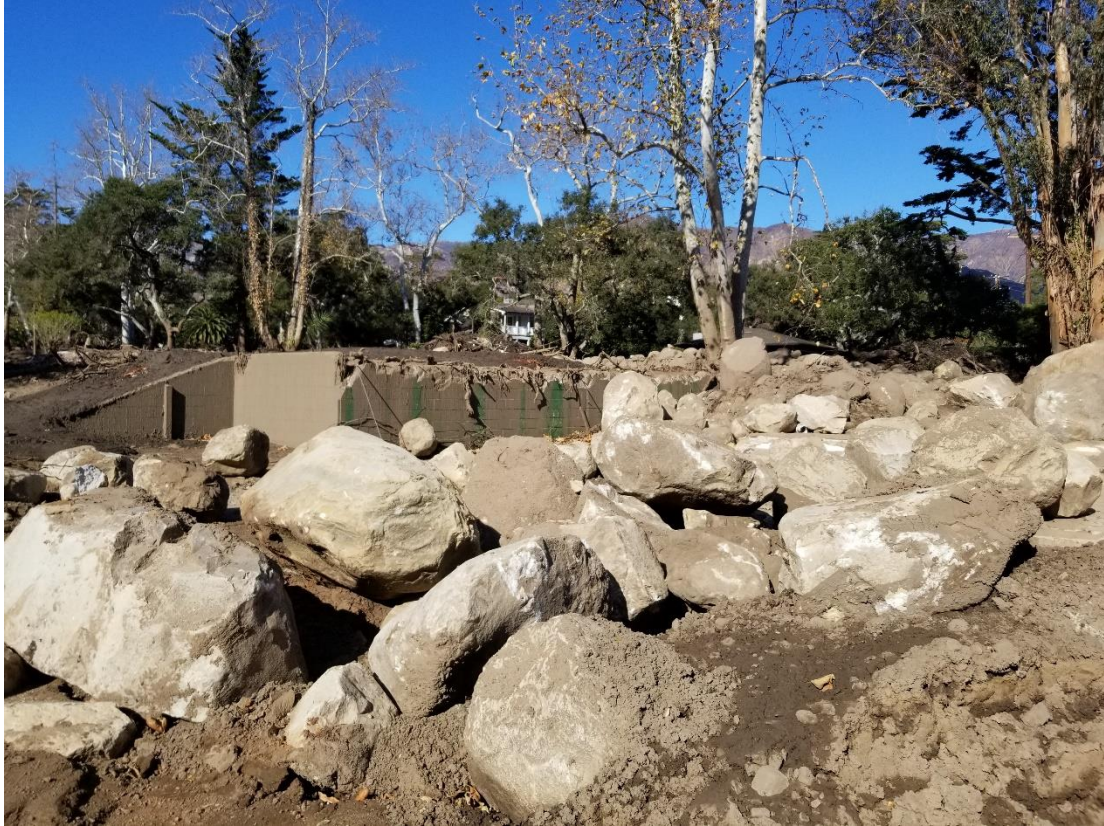
The foundation of a home remains after the devastating impacts of large boulders completely destroyed the home located next to Montecito Creek.

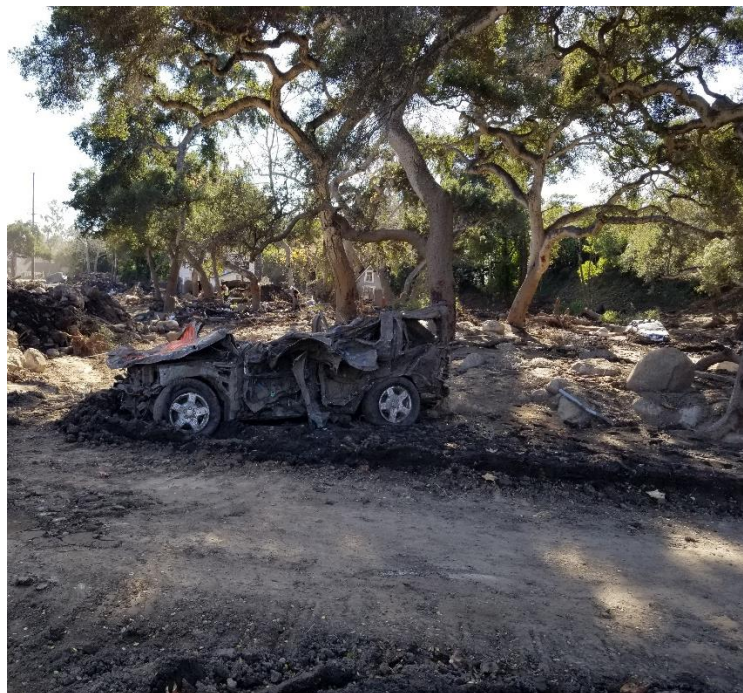
Boulders and log debris cause severe destruction along the flow paths and this automobile exhibits the results of these impacts.

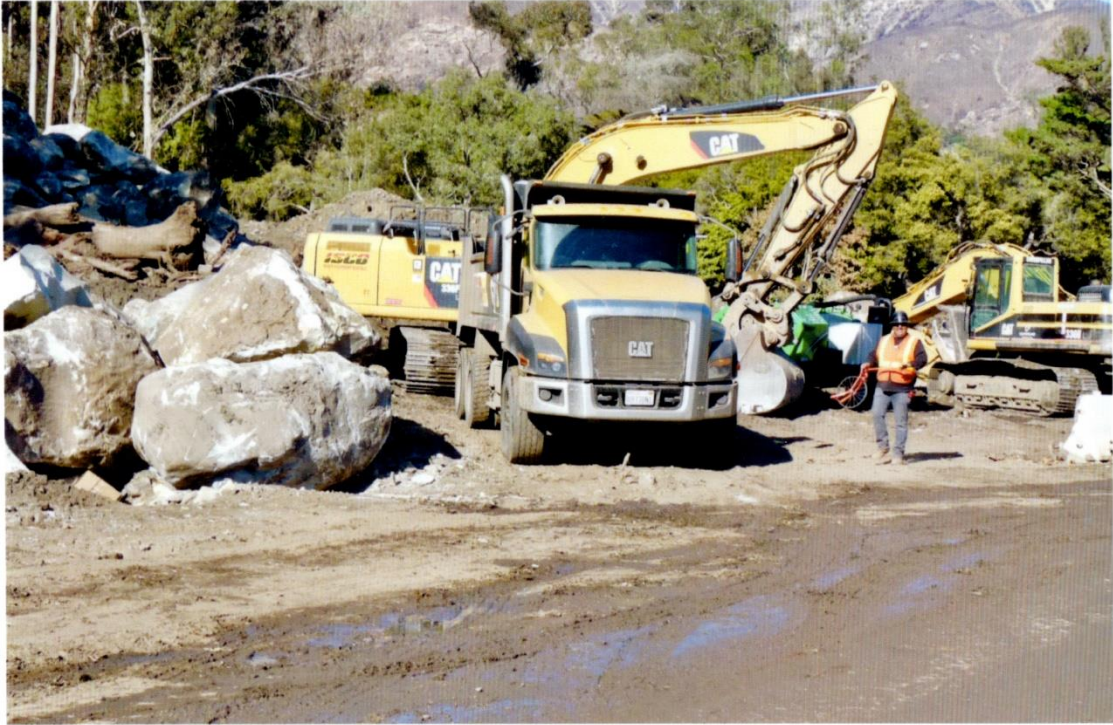
Clean up of massive boulders in Montecito following the 1-9 event. Photograph from the Montecito Association History Committee.

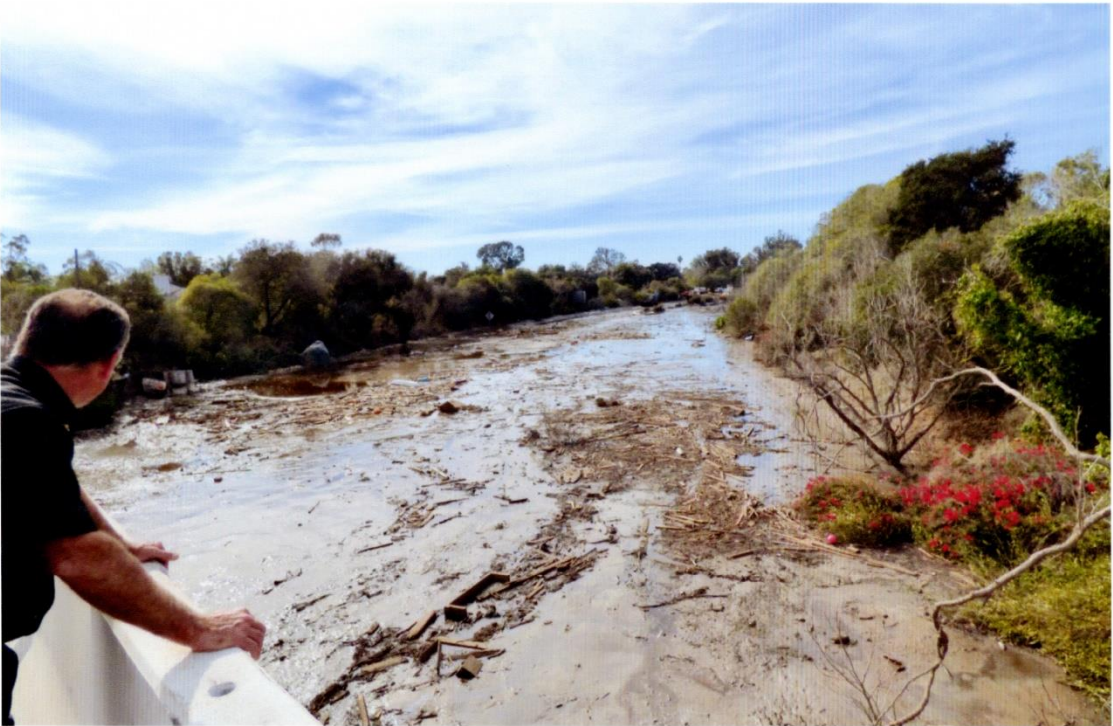
Mud and debris cover Highway 101 below Olive Mill Road. Photograph from the Montecito Association History Committee.

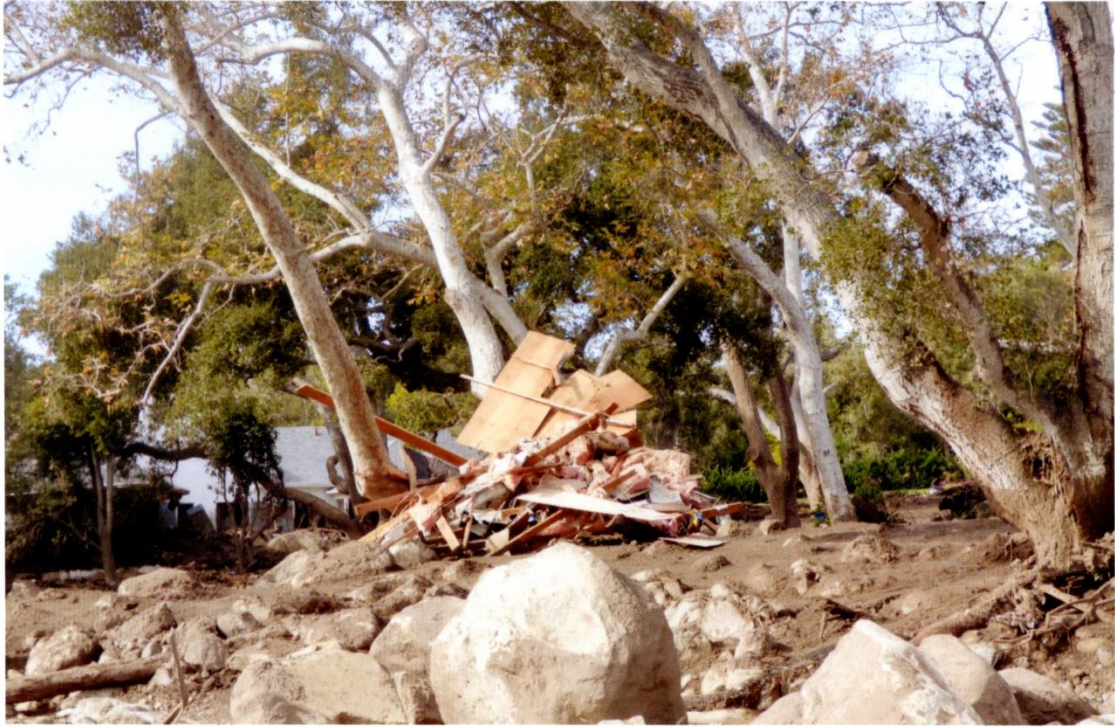
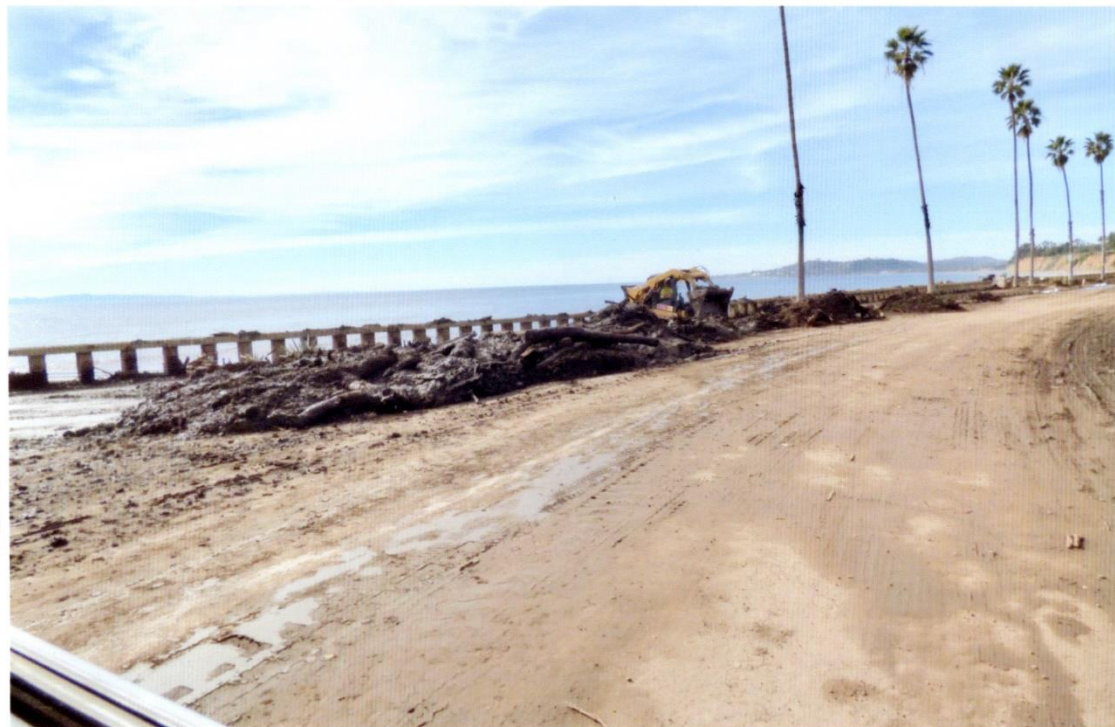
Upper photograph: Boulder and entrained debris cover the area of the lower fan in Montecito. Lower photograph: Mud and debris cover Channel Drive at Butterfly Beach. Photographs from the Montecito Association History Committee.

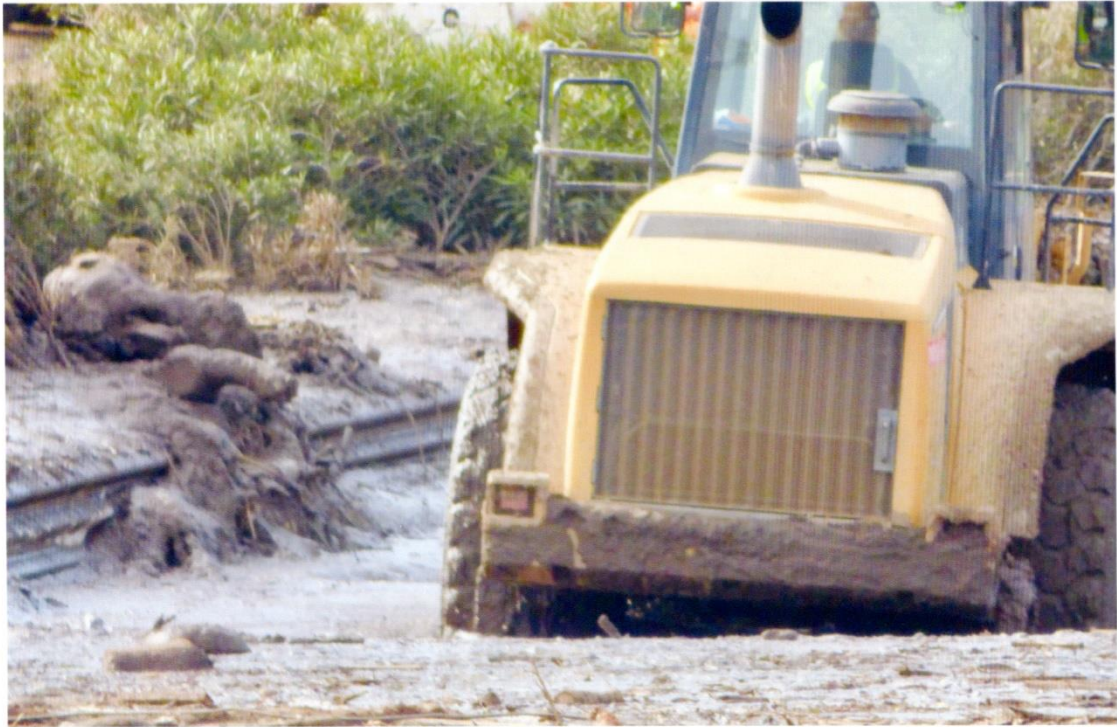
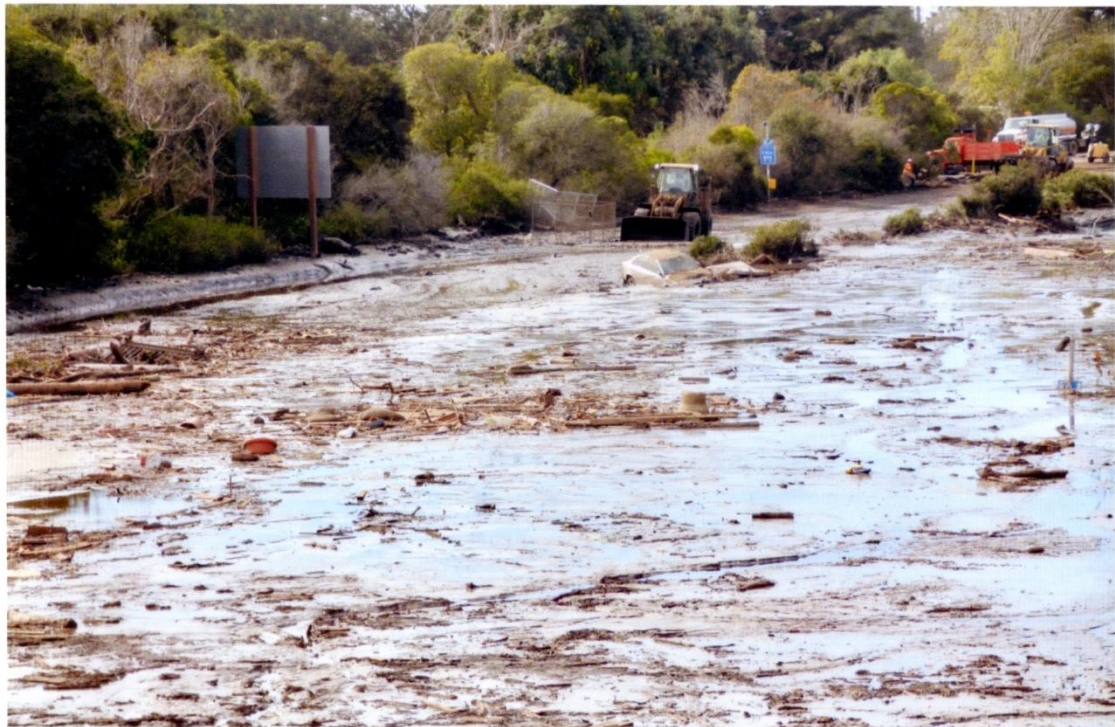
Upper photograph: A loader works to clear debris from Highway 101. Lower photograph: Mud and debris fill the topographically low area of Highway 101 which acts as a debris basin below Olive Mill Road. Photographs from the Montecito Association History Committee.

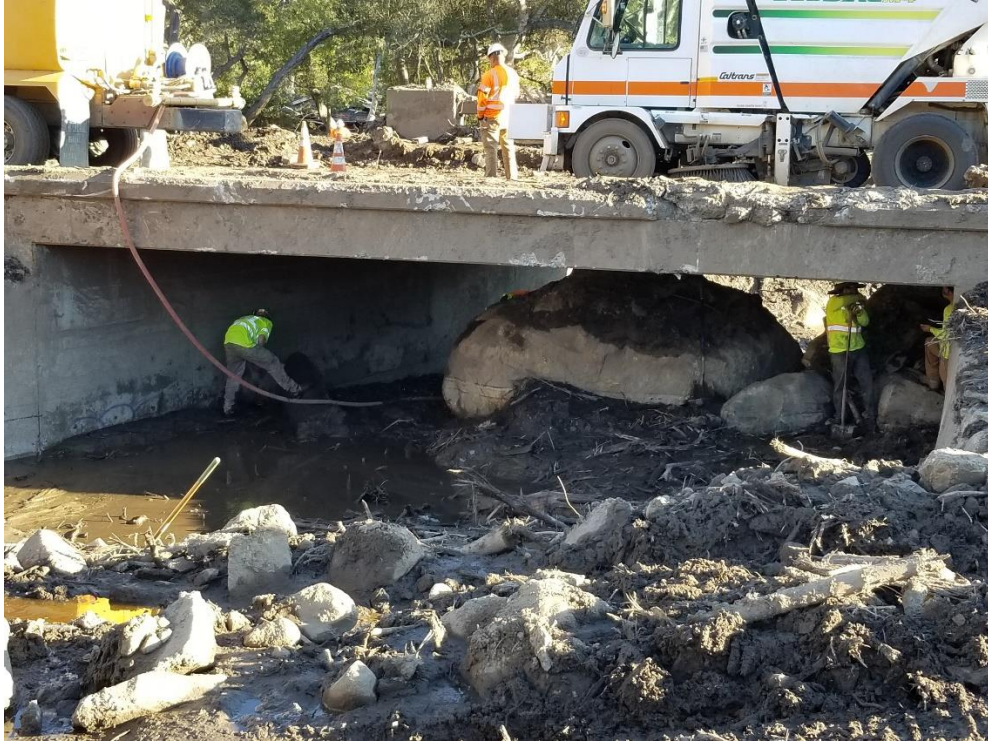
Crews work to clear the debris blockage under the Highway 192 bridge crossing on San Ysidro Creek, however a massive boulder is lodged in the constriction. The photograph is to the southeast on the upstream side of the bridge which obliterated the railings.

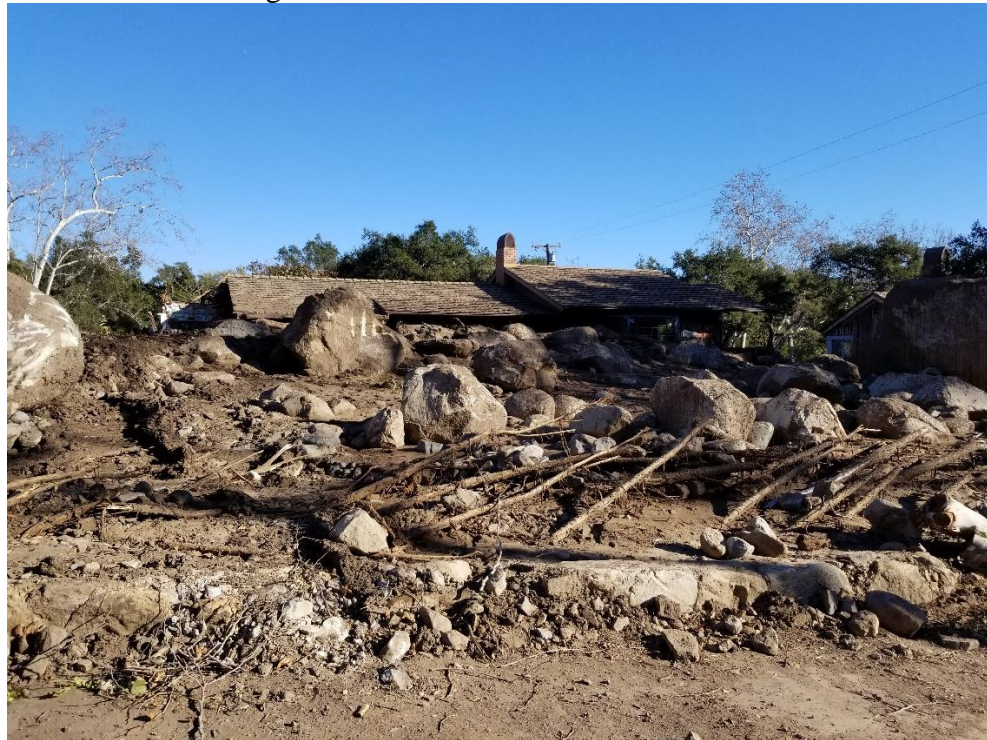
Boulders and log debris downstream of the Highway 192 bridge in the Glen Oaks area of Montecito.

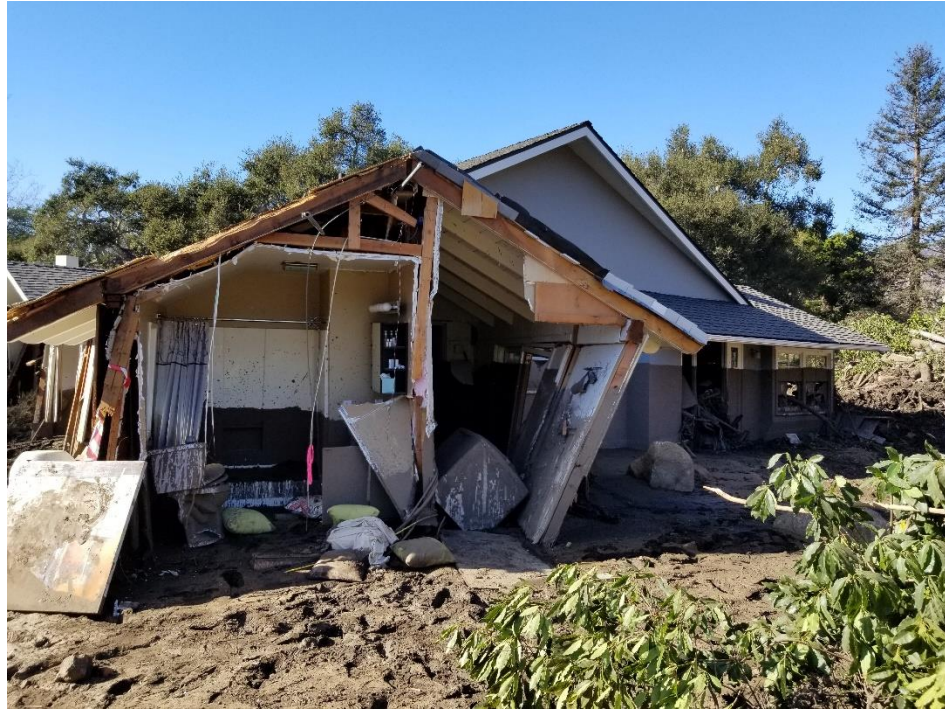
A residence destroyed along San Ysidro Creek on the lower part of the alluvial fan.

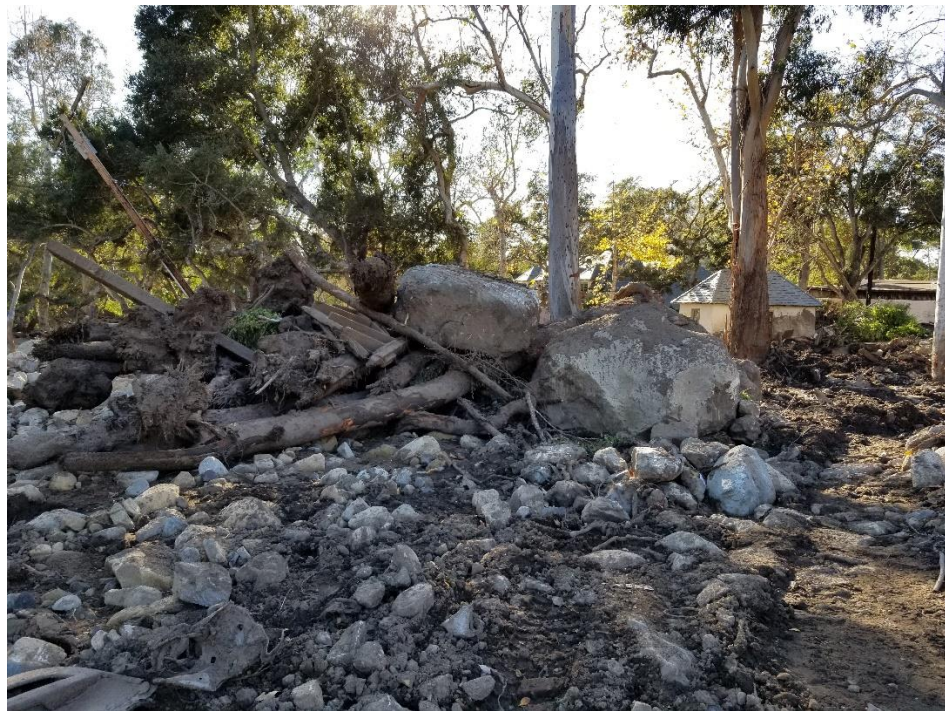
A snag of boulder and log debris along the flow paths in the lower part of the fan.
